## **STRUCTURAL ASSESSMENT REPORT**

**Albion Park Butter Factory (Former)  
23 Calderwood Road, Albion Park NSW 2527**

**INGLIS Project No: 2020136  
Report Reference No: 2020136-RPT-001**

**Report Date: 18 August 2021**

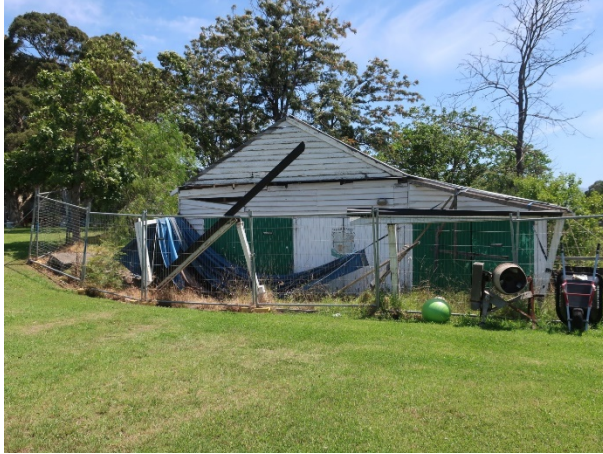
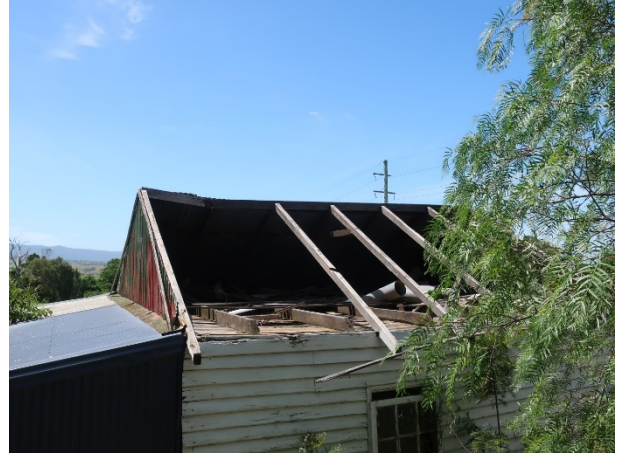
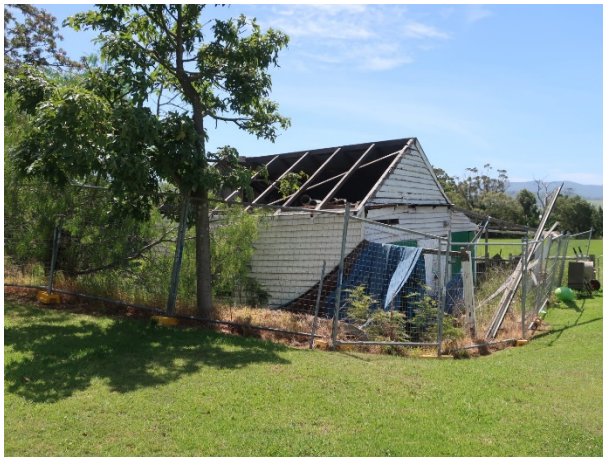
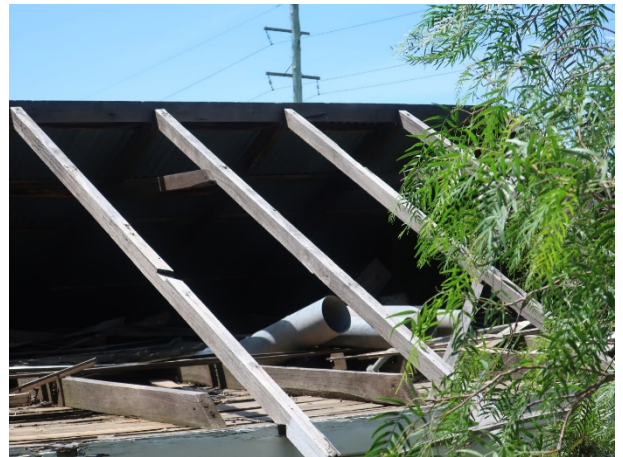
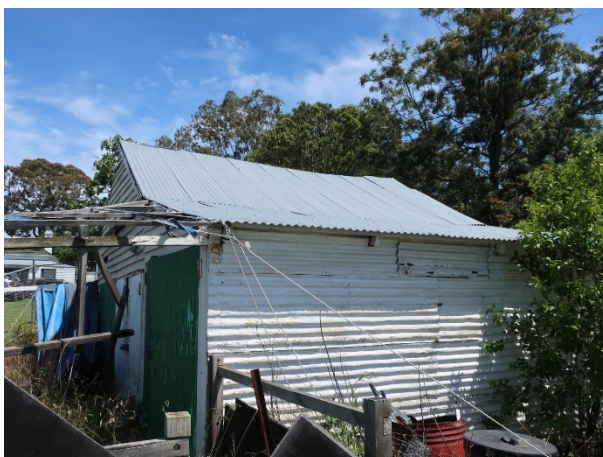
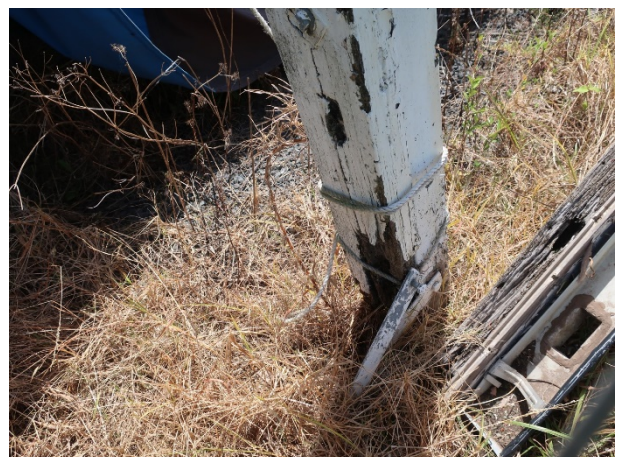
Structure: Building  
Element: External

Inspection History			
Inspection Date	19/11/20		
Likelihood Score	D		
Consequence Score	3		
Risk Rating	Medium		
Priority	3		
Photo Record	As Shown and Refer Appendix A.		
Observations/Comments

- The majority of the eastern verandah has collapsed and is dilapidated beyond repair.
- The pitched roof framing is partially collapsed and the structural integrity of the roof framing is compromised. The roof sheeting and battens on the southern side are missing. In the current state the remaining roof frame may be dislodged and become airborne debris and any significant wind storm event.

- Moderate rotting and termite damage in some of the exposed timber roof frame members.
- Moderate rotting and termite damage in the external timber framed windows, doors and associated frames.

- Moderate to severe deterioration of weatherboards including peeling and general degradation of painted surfaces.
- Dislodged and missing weatherboards.

- The structure is partially enclosed by a security fence albeit still accessible.
- This risk assessment is based on the current compromised state of the security fence. We recommend installation of a security fence around the entire building with provision of a locked access gate. The security fence should be maintained until remedial works are complete. If unauthorised access is restricted the risk rating will revert to Low.

- 5.3.2. Engage a licenced builder to undertake temporary make-safe repairs to the roof framing, tiedown, bracing and roof sheeting. In the current state the remaining roof frame may be dislodged and become airborne debris and any significant wind storm event.

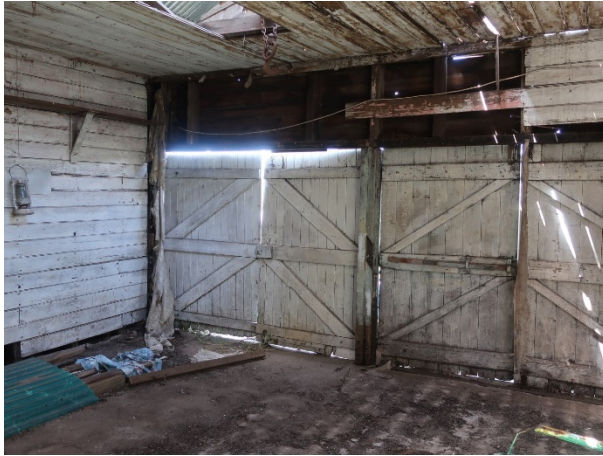
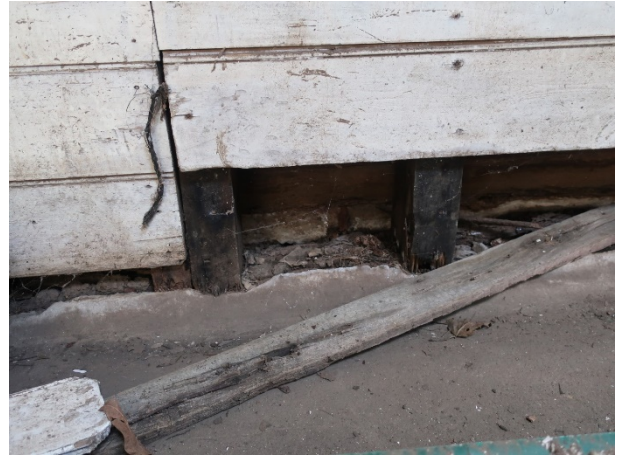
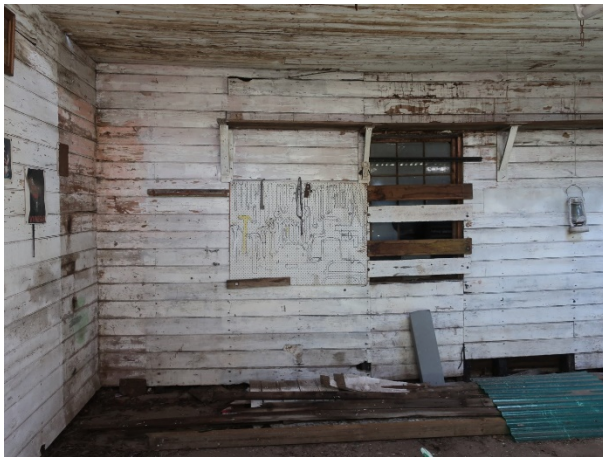
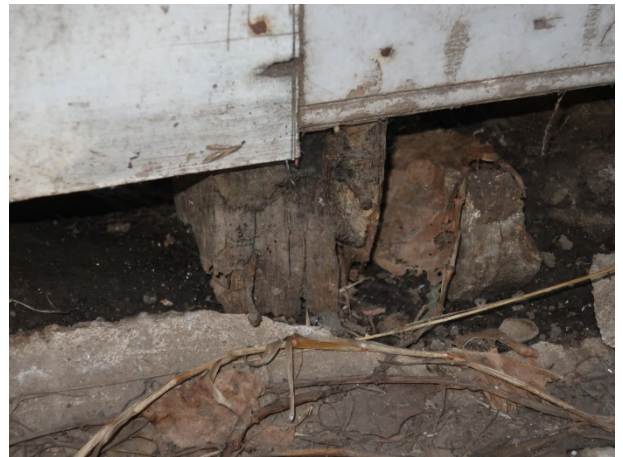
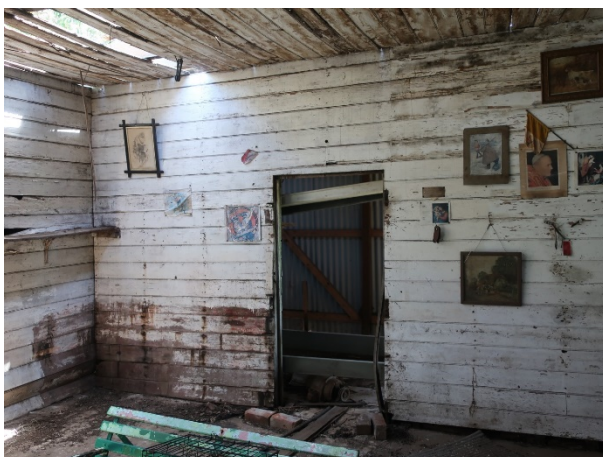
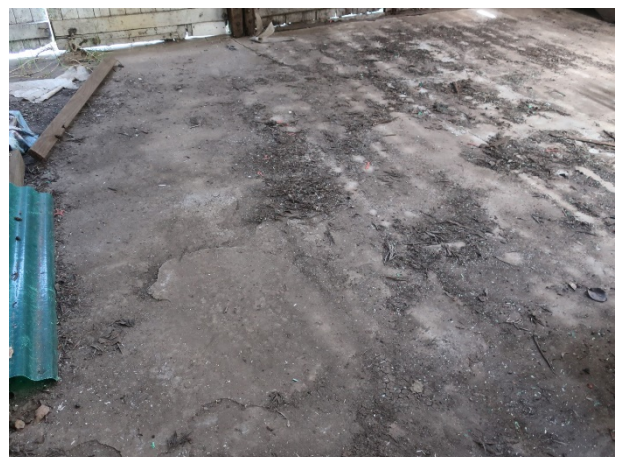
Structure: Building  
Element: Internal

Inspection History			
Inspection Date	19/11/20		
Likelihood Score	D		
Consequence Score	3		
Risk Rating	Medium		
Priority	3		
Photo Record	As Shown and Refer Appendix B.		
Observations/Comments

- Moderate to severe rotting and termite damage in some of the exposed timber wall frame members.
- Moderate rotting and termite damage in the internal timber framed windows, doors and associated frames.

- Moderate to severe deterioration of wall and ceiling lining boards including peeling and general degradation of painted surfaces.
- Extensive dislodged and missing wall and ceiling lining boards.

- Moderate cracking, spalling and settlement of the concrete floor slab.

- The structure is partially enclosed by a security fence albeit still accessible.
- This risk assessment is based on the current compromised state of the security fence. We recommend installation of a security fence around the entire building with provision of a locked access gate. The security fence should be maintained until remedial works are complete. If unauthorised access is restricted the risk rating will revert to Low.

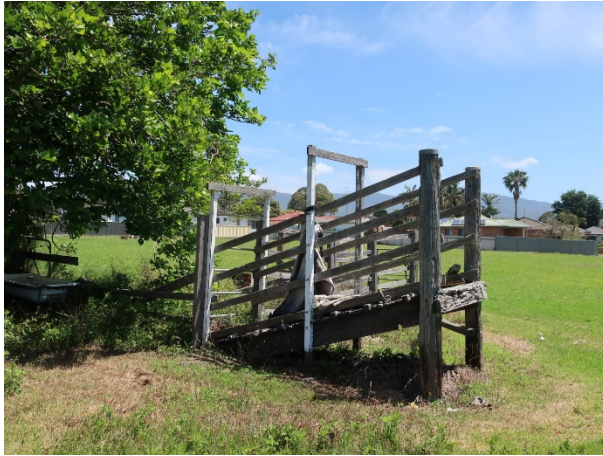
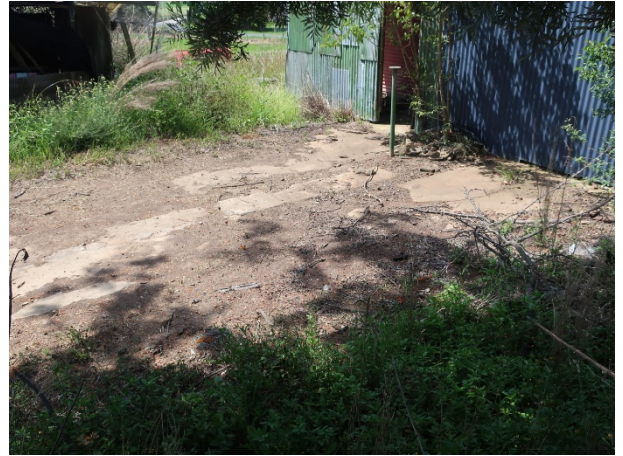
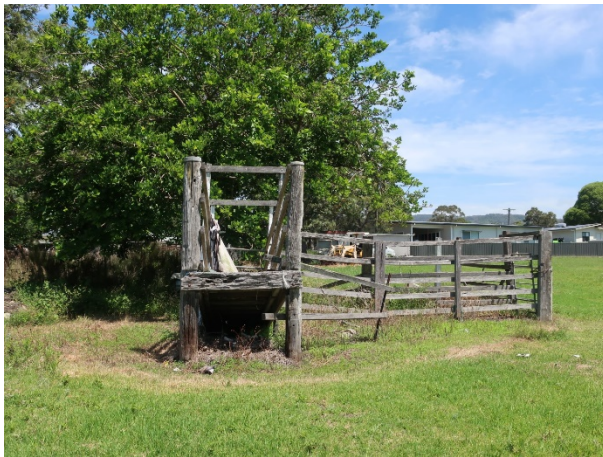
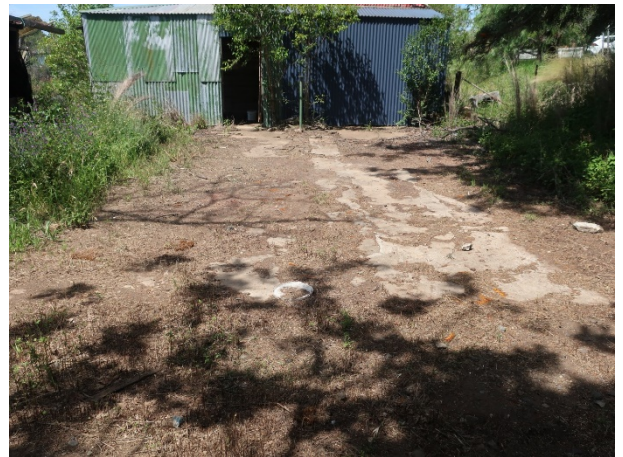
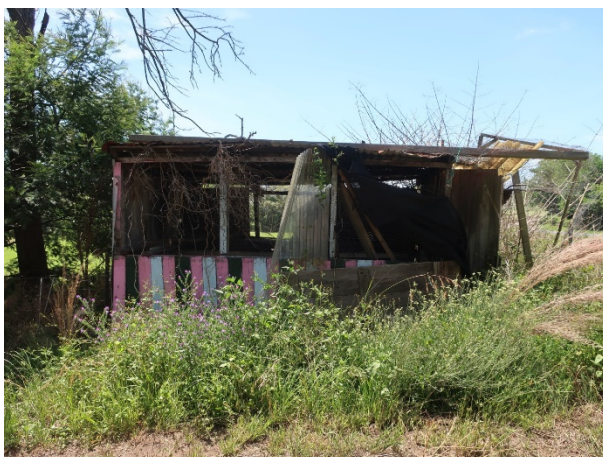
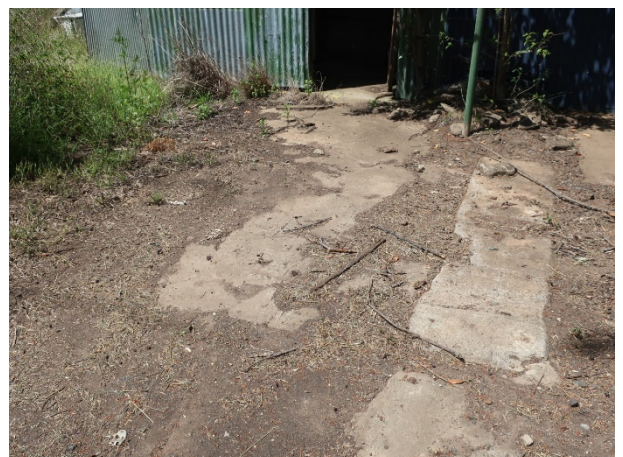
**Structure: Miscellaneous**

Inspection History			
Inspection Date	19/11/20		
Likelihood Score	E		
Consequence Score	2		
Risk Rating	Low		
Priority	4		
Photo Record	As Shown and Refer Appendix C.		
Observations/Comments			
<ul style="list-style-type: none"> <li>• Moderate cracking, spalling and settlement of the external concrete and stone pavement.</li> <li>• Dilapidated chicken coop/shed. We understand this item is not of heritage significance.</li> <li>• Moderate rotting, termite damage and general dilapidation of the timber framed cattle yards and loading ramp. We understand these items are not of heritage significance.</li> </ul>
