PRELIMINARY SITE INSPECTION

Preliminary Site Investigation & Limited Site Assessment

Tripoli Way Extension, Albion Park
NSW

1 February 2022

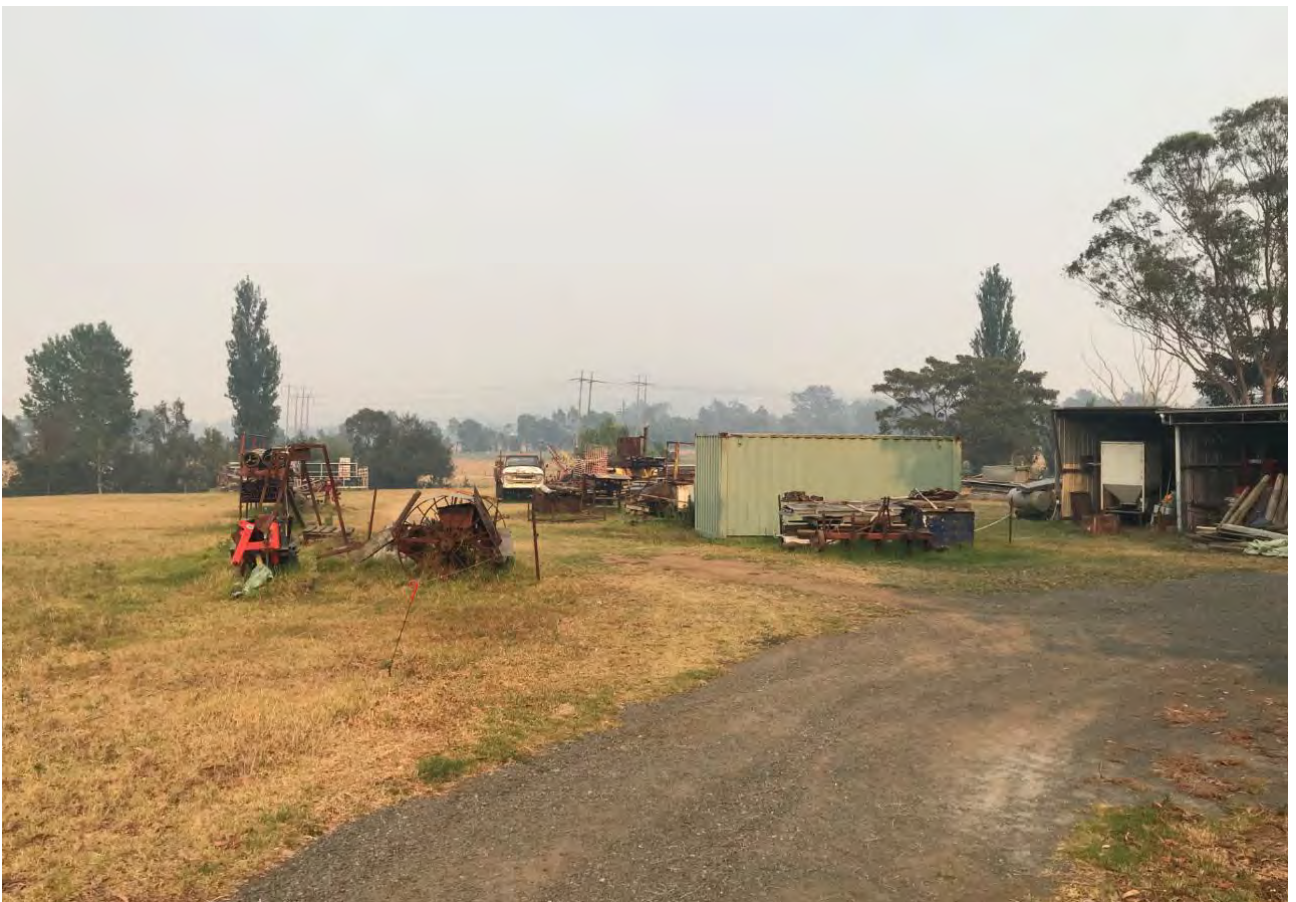
Photograph 8: a laydown area of mostly agricultural equipment within Lot 1 in DP559819 (AEC02)

Item	Observations
	irrigation pipe, rusted metal parts and a disused truck (see Photographs 8 to 10 of Appendix B).
Stockpiles	<p>Several stockpiles were observed in Lot 1182 in DP1202087 at the western extremity of the site, however, the nature of the stockpiled material was unable to be determined as access to the area was limited (see Photograph 3, 26 and 27 of Appendix B).</p> <p>Two stockpiles were observed in Lots 11 and 12 of DP1205733 within close proximity to the former Albion Park Dairy (see Photograph 12 and 13 of Appendix B). The contents of each stockpile were unable to be assessed as the stockpiles were vegetated with grass.</p>
Liquid waste disposal features	None observed, however, the township of Albion Park is connected to the local sewer network so wastewater is inferred to be managed by Sydney Water.
Evidence of previous site contamination investigations	None observed.
Evidence of land contamination (staining or odours)	None observed.

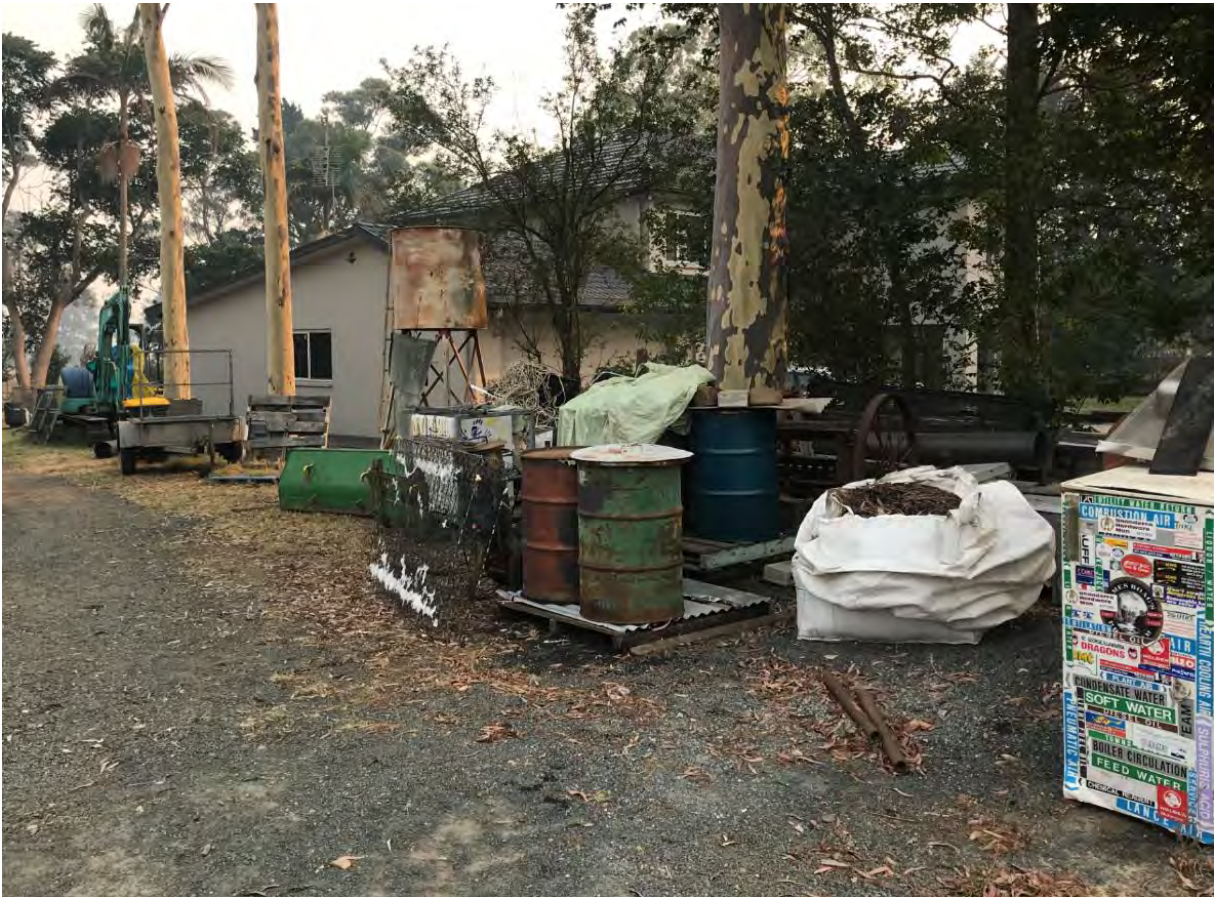
Photograph 9: drums and an aboveground storage tank located immediately north of AEC02

Fuel storage tanks (USTs/ASTs)	<p>Evidence of Underground Storage Tanks (USTs) or aboveground storage tanks (ASTs) for fuel storage were not observed during the site visit. An AST with an approximate volume of 500L was observed within the southern portion of Lot 1 in DP559819 (see Photograph 9 of Appendix B), however, it was situated approximately 10m north of the site. Significant staining was not observed on the ground surface beneath the AST.</p>
Dangerous goods	<p>Storage of dangerous goods was not observed during the site inspection.</p>
Solid waste deposition	<p>Solid waste was observed at the following locations within the site:</p> <ul style="list-style-type: none"> At the far western extremity of the site within Lot 1182 in DP1202087 where a laydown area and large stockpiles were observed (see Photograph 3, 26 and 27 of Appendix B). The land is believed to be under occupation by Lend Lease during the Calderwood residential development and was inaccessible at the time of the inspection. The nature of the stockpiled material was unable to be confirmed due to the distance from which observations were made, however, it appeared to be construction materials and waste including concrete, asphalt and coal washery reject. Aerial imagery accessed using Nearmap suggests that the area has been used as a laydown and storage area since at least May 2017. Minor filling within Hazleton Creek in the western portion of the site within Lot 1182 in DP1202087 and Lot 1 in DP559819. Filling was mostly evident around creek crossings that appear to have been constructed using concrete culverts and backfill including soil and demolition rubble (see Photographs 2 and 11 of Appendix B). Trace quantities of litter were observed within Hazleton Creek but is inferred to be runoff from the upgradient Illawarra Highway. A significant quantity of farming equipment and other miscellaneous materials were observed during the inspection of the southern portion of Lot 1 in DP559819 which is a rural-residential property located west of The Expressway. The materials observed included discarded refrigerators, steel drums, metal farming equipment including

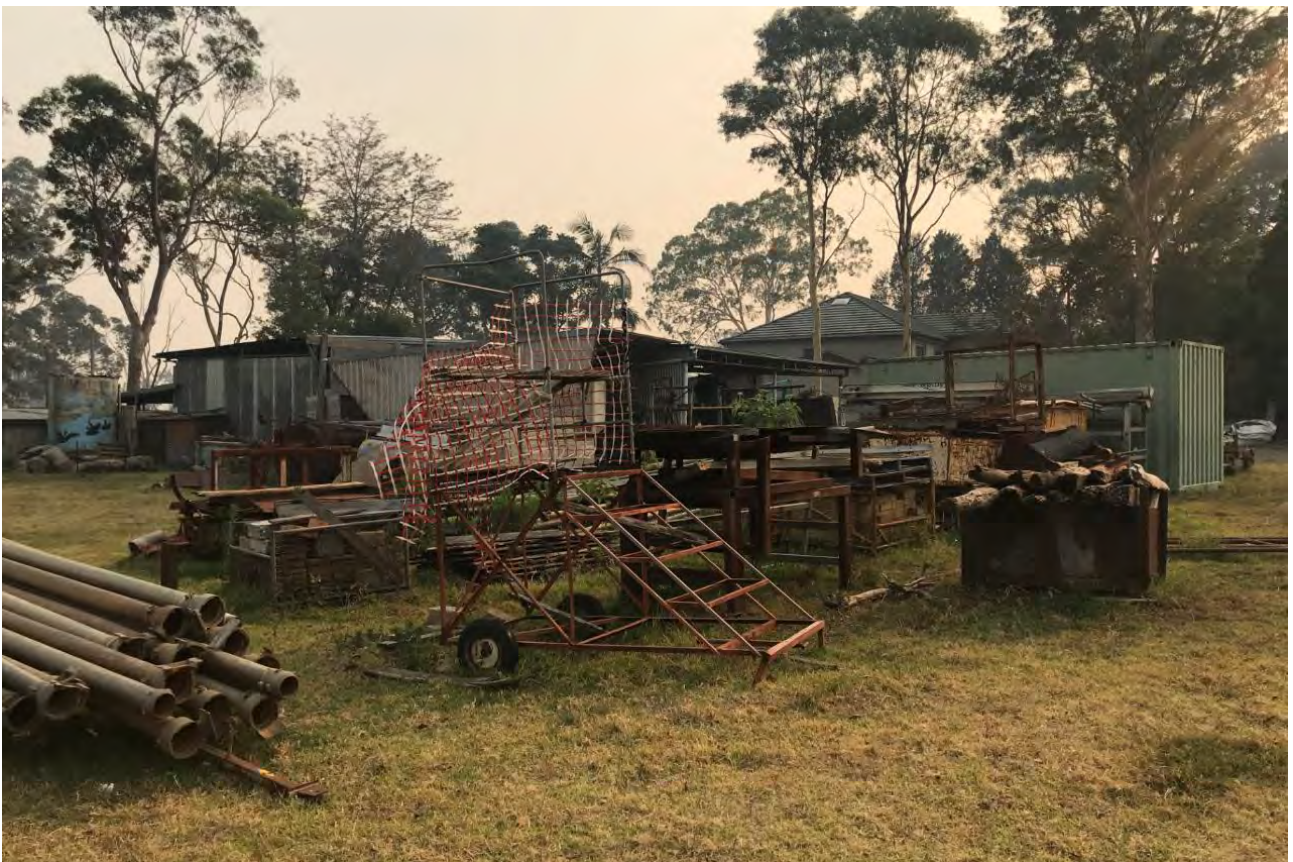
Photograph 10: a laydown area of mostly agricultural equipment within Lot 1 in DP559819 (AEC02)

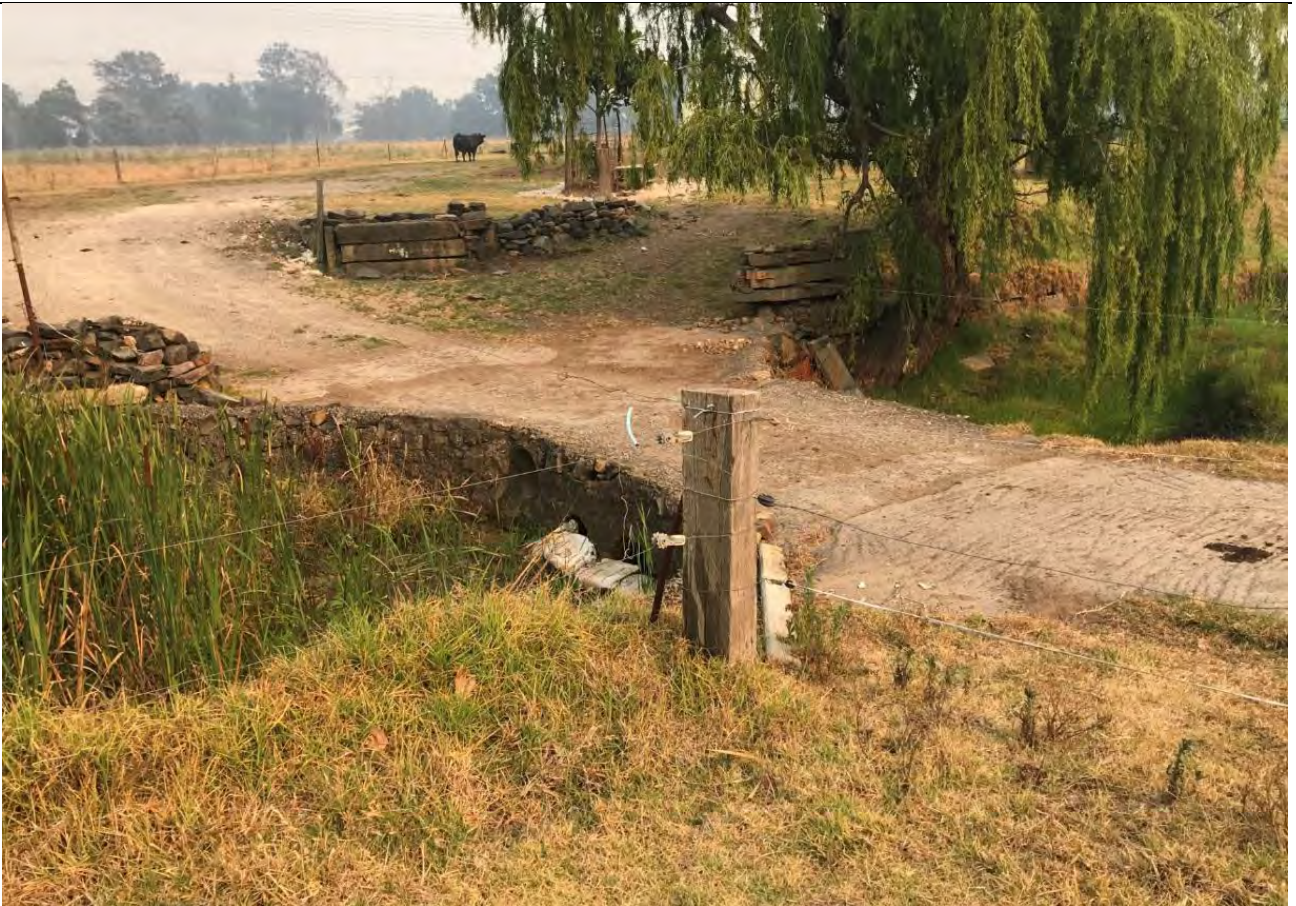
Photograph 11: a creek crossing over Hazleton Creek observed within Lot 1 in DP559819, constructed of rock, concrete with several concrete culverts observed

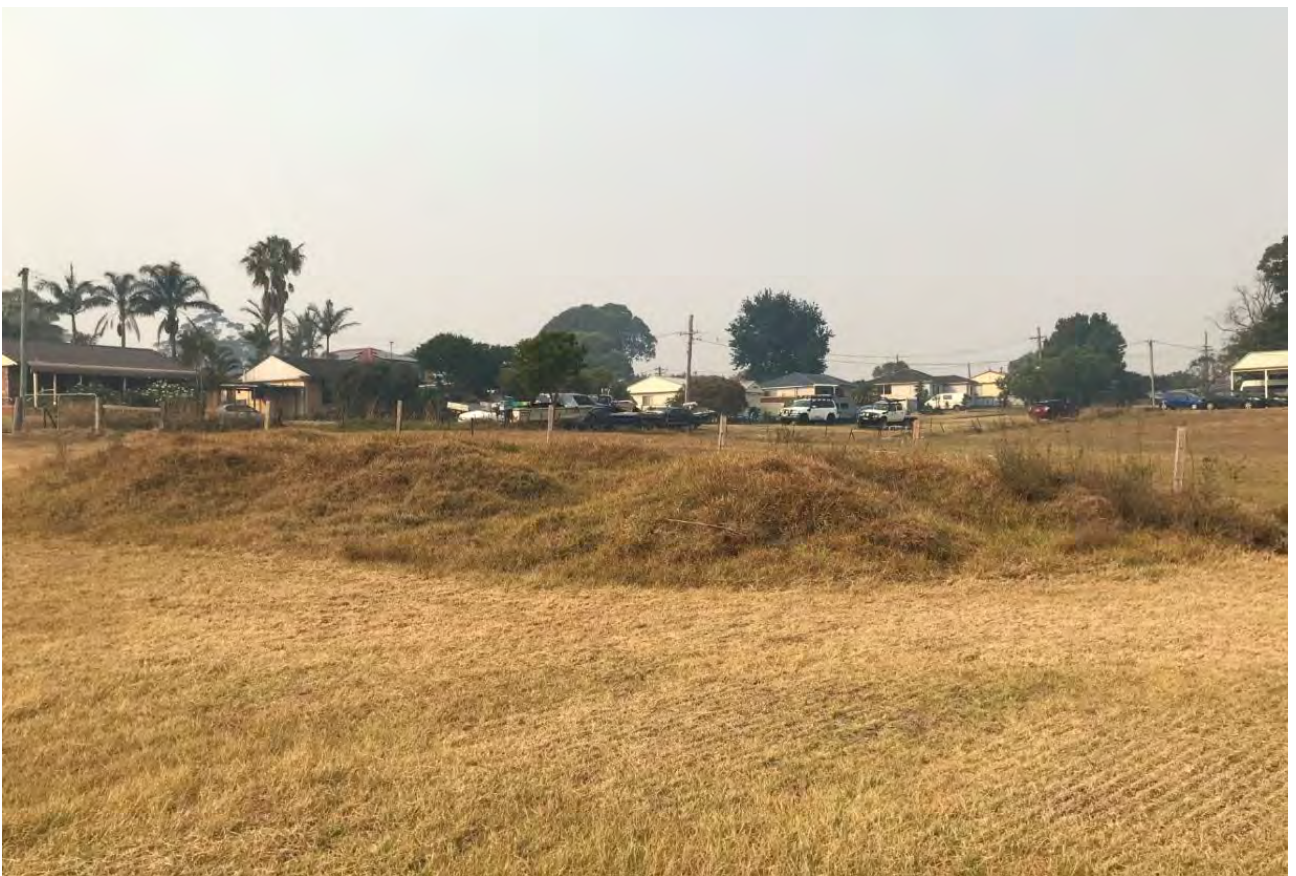
Photograph 12: a stockpile observed within Lot 11 of DP1205733 (AEC04)

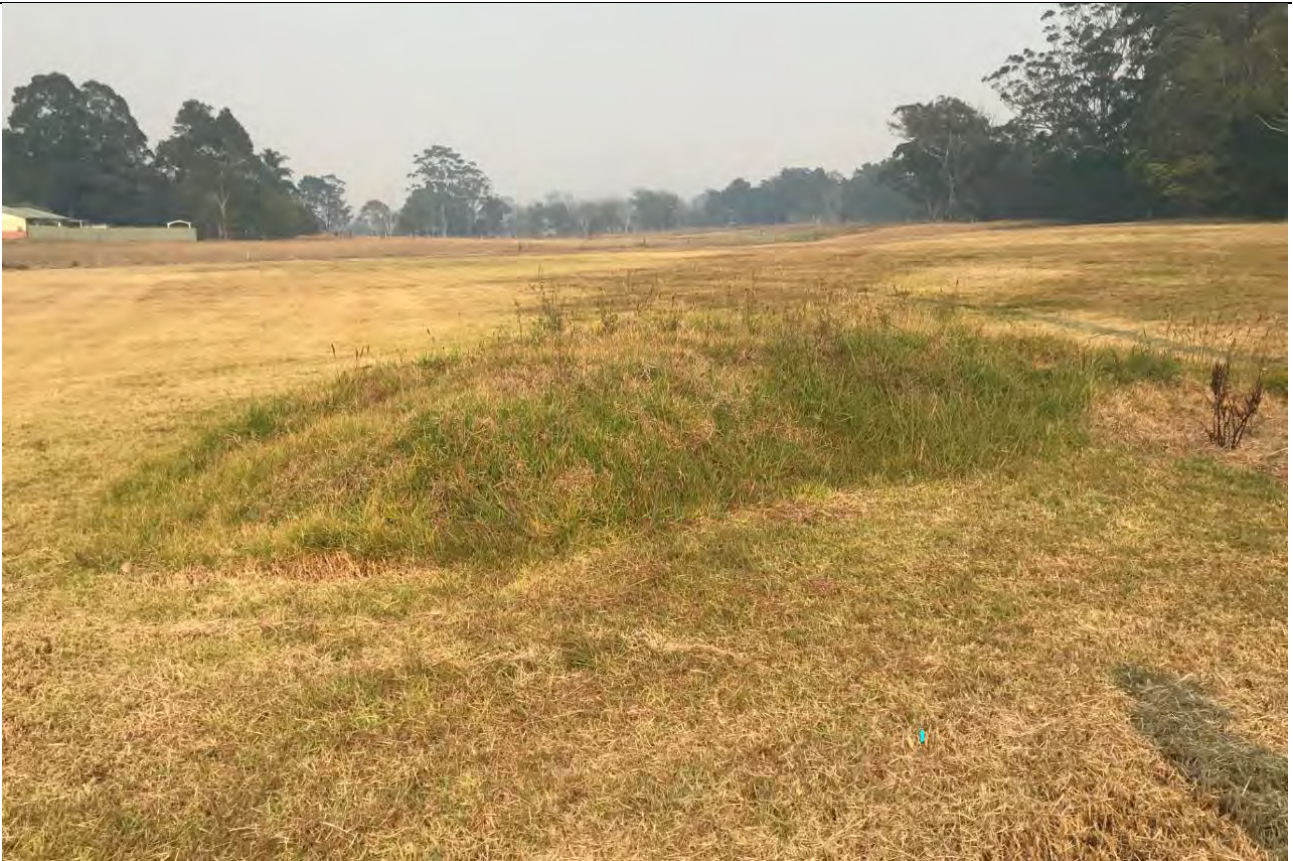
Photograph 13: a stockpile observed within Lot 11 of DP1205733 (AEC04)

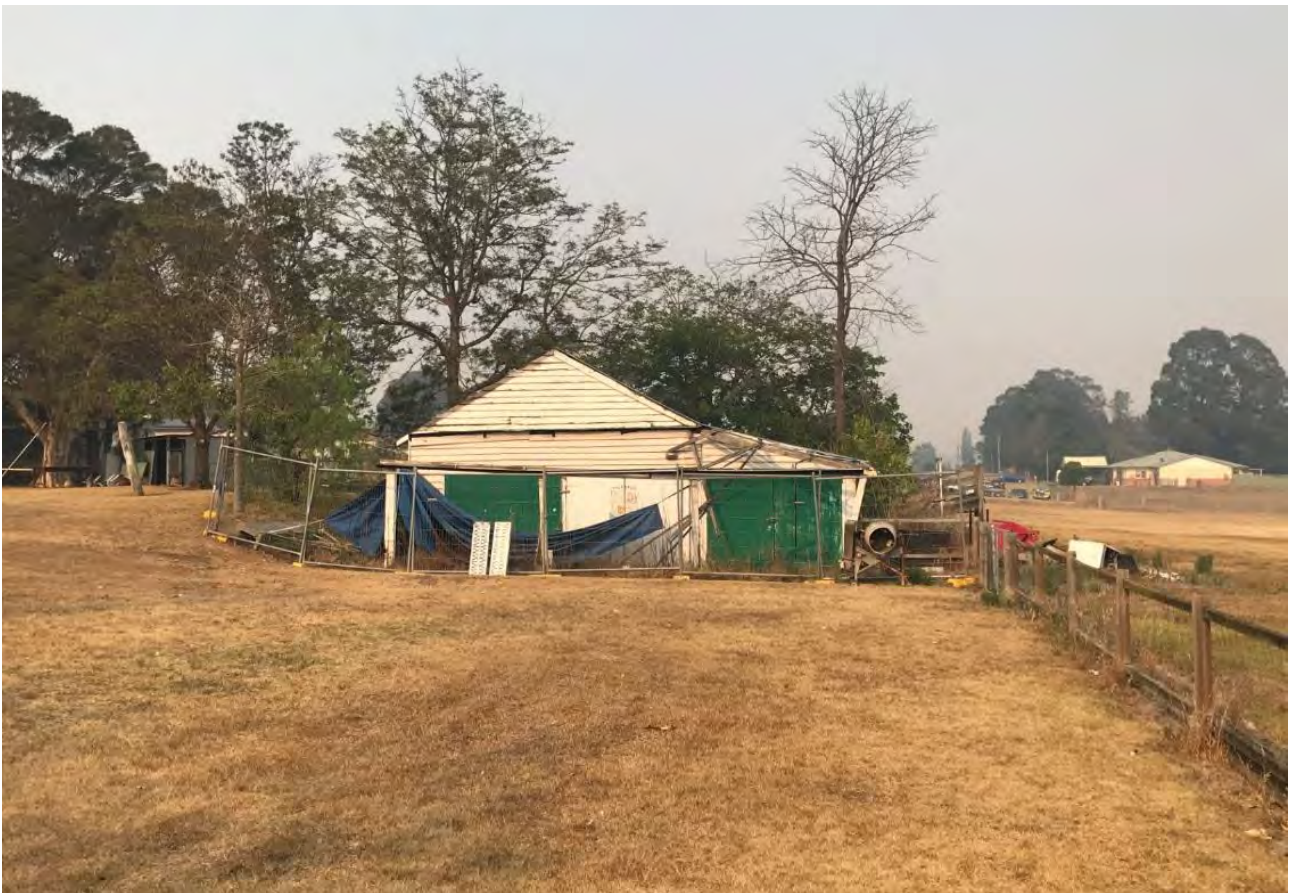
Photograph 14: the former “Tulkeroo” Butter Factory located in Lot 12 / DP 1205733 (AEC03)

Former Dairy and Butter Factory (AEC03)	The former "Tulkeroo" Butter Factory is located in Lot 12 / DP 1205733 and operated between 1887 to 1908. Depending on the scale of the operation there may have been potential contaminant sources at the site associated with industrial processes such as storage of petroleum products. Whilst potential contamination associated with the operations may have degraded, such as hydrocarbons, it is possible that more persistent contaminants may still exist. Current and former structures may also have been constructed of hazardous building materials such as asbestos and/or lead based paints.	<ul style="list-style-type: none"> > Heavy metals > PAHs; > TRHs;
Stockpiles (AEC04)	Two stockpiles were observed in Lots 11 and 12 / DP1205733 north of the former "Tulkeroo" Albion Park Dairy. The contents of each stockpile were unable to be assessed as the stockpiles were vegetated with grass during the walkover	<ul style="list-style-type: none"> > BTEXN; > Phenols; > OCP;

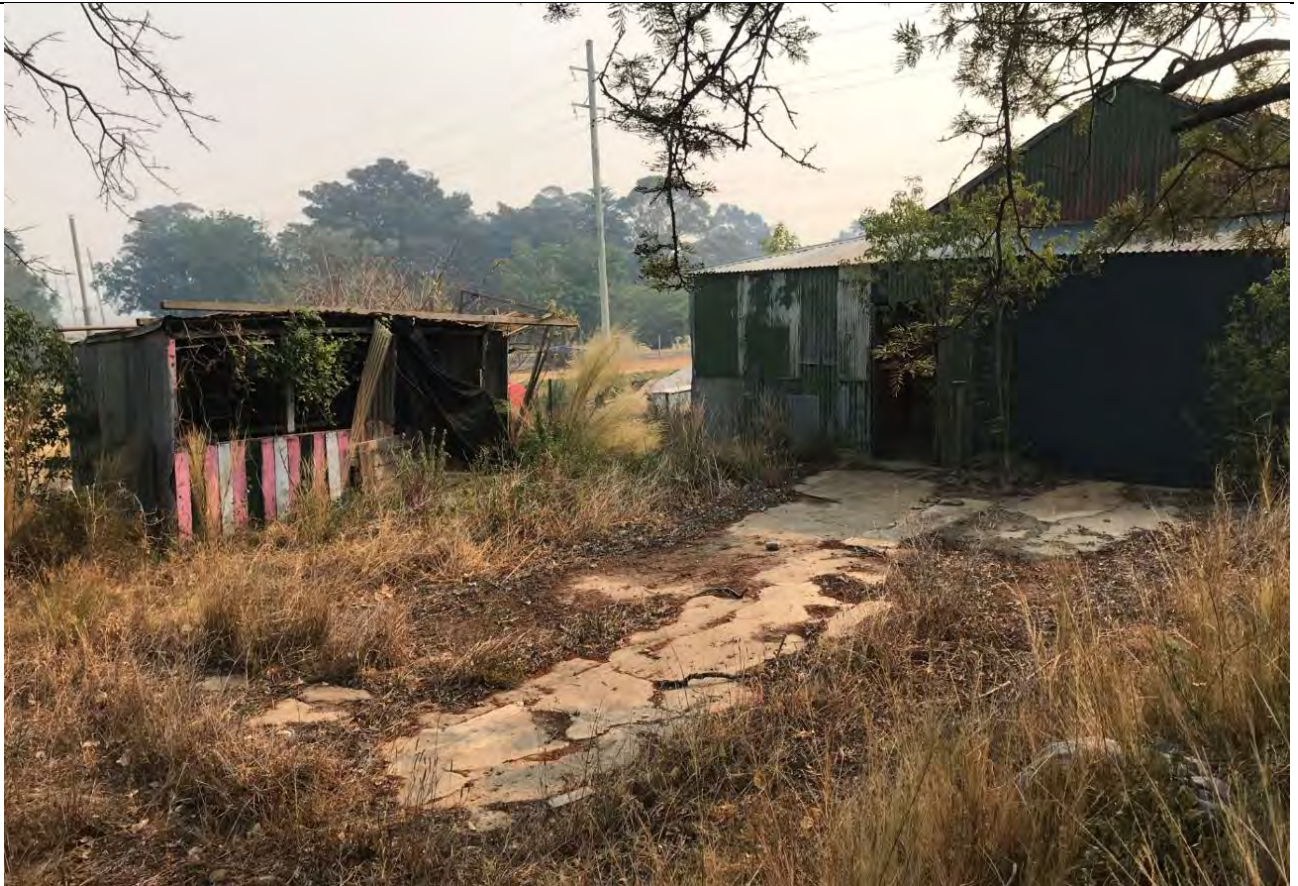
Photograph 15: the western portion of the “Tulkeroo” Butter Factory located in Lot 12 / DP 1205733 (AEC03)

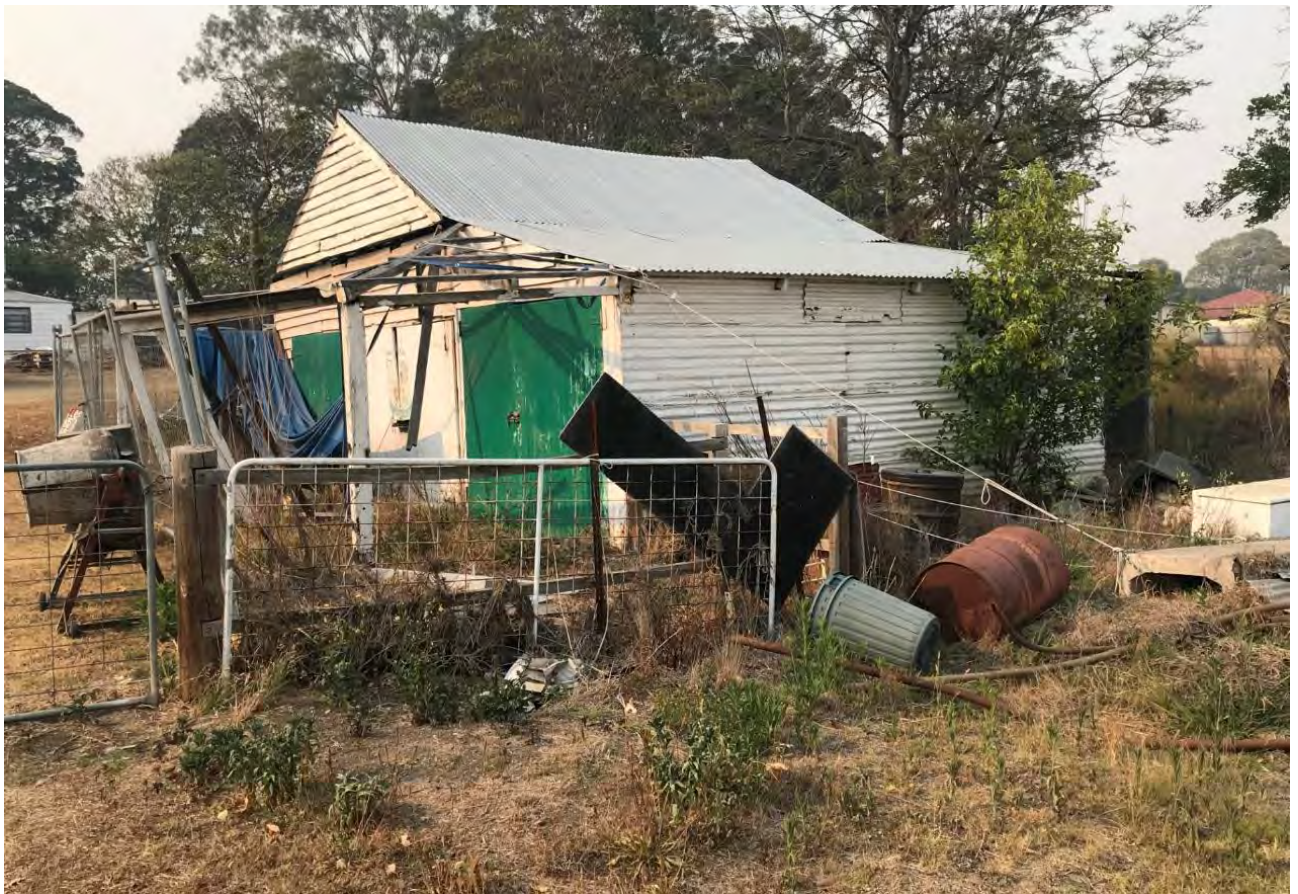
Photograph 16: the former “Tulkeroo” Butter Factory located in Lot 12 / DP 1205733 (AEC03), with drums and other discarded waste surrounding the structure

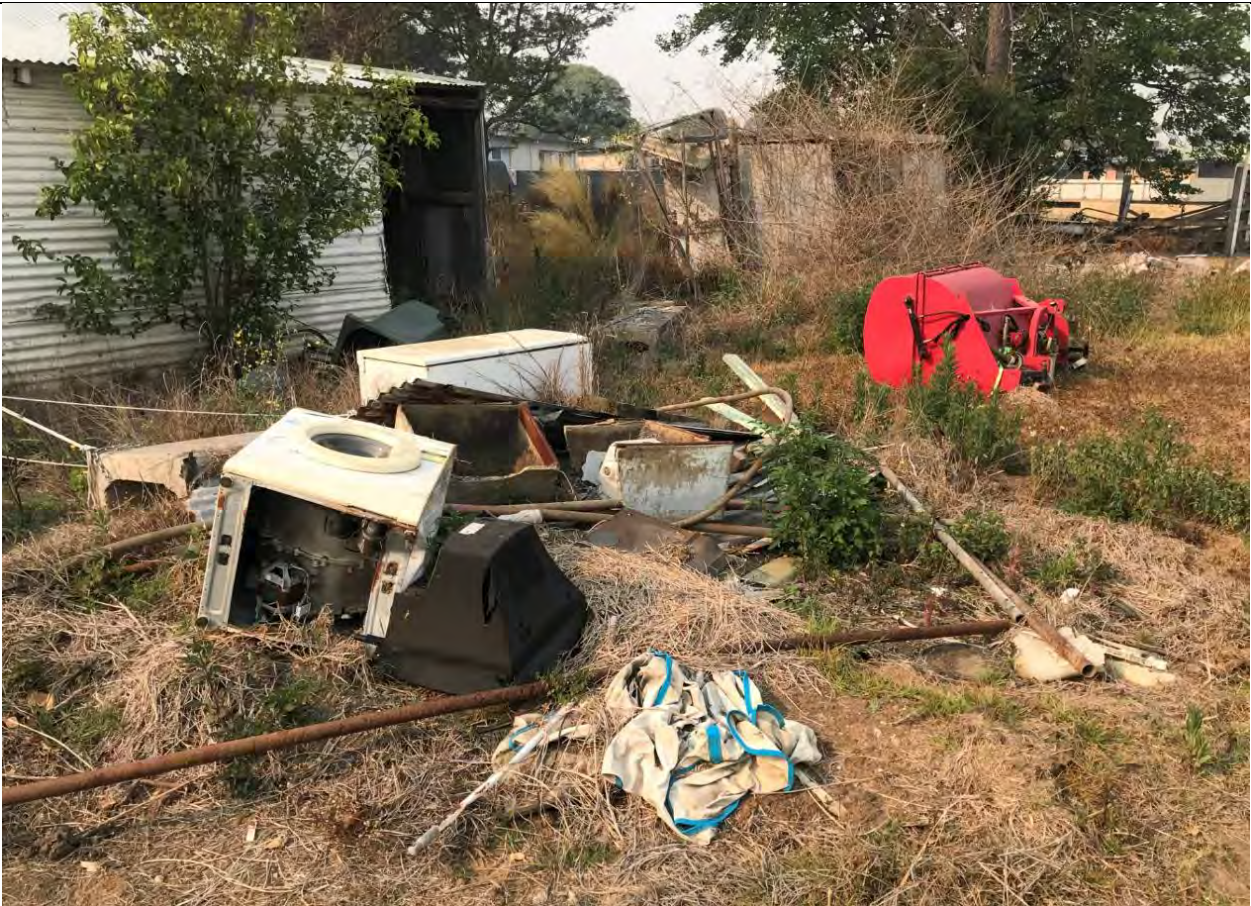
Photograph 17: waste observed immediately north of the "Tulkeroo" Butter Factory located in Lot 12 / DP 1205733 (AEC03)

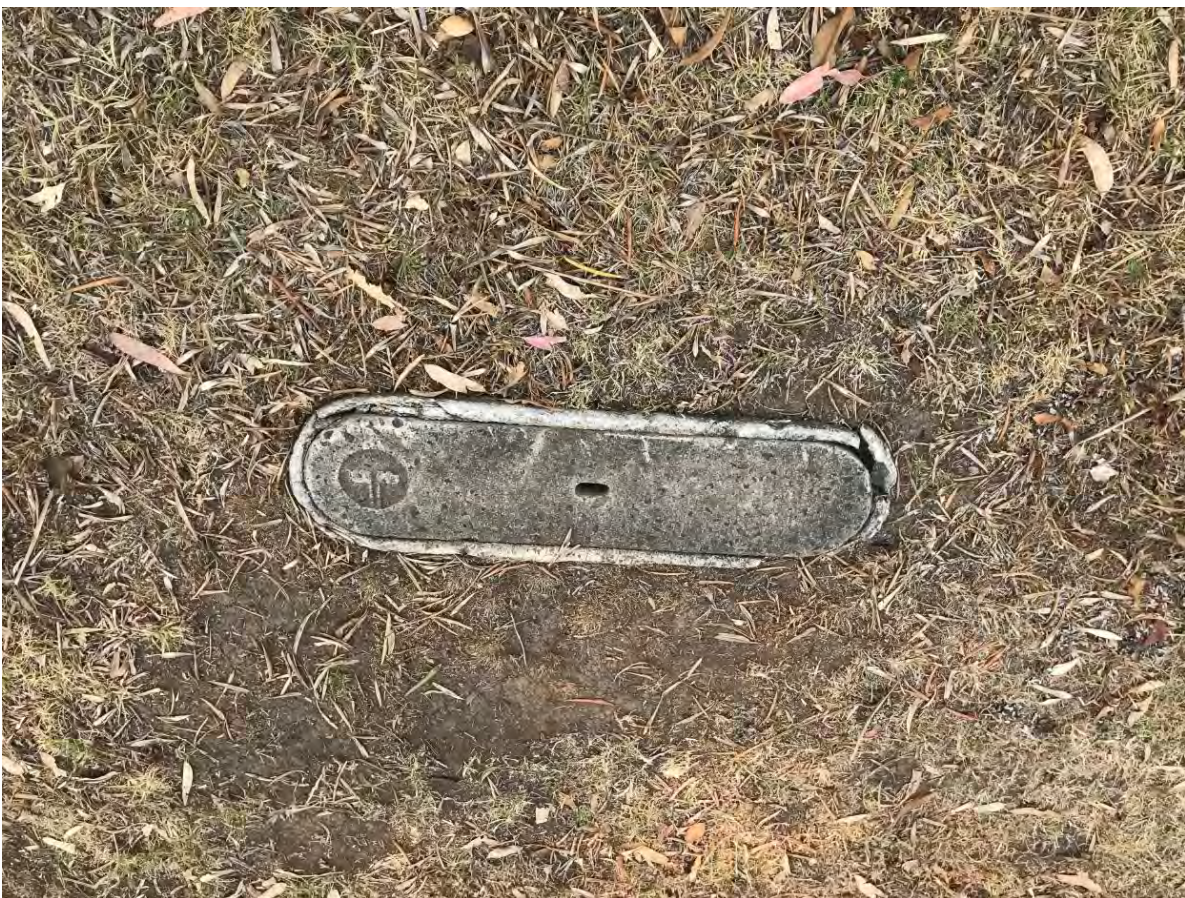
Item	Observations
	<ul style="list-style-type: none"> Several buildings were visible in Lot 4 in DP714125, however, access to this lot was not permitted so an assessment of the buildings was unable to be completed. <p>Structures within the site were limited to fences and road infrastructure including pavement, street lights, reflector posts and signage. Two creek crossings across Hazleton Creek were also observed in the western portion of the site, one within Lot 1182 in DP1202087 and the other in Lot 1 in DP559819 (see Photographs 2 and 4 of Appendix B).</p>
Existing Services	<p>Services within the site were unable to be identified in their entirety due to the large site area, however, it is assumed that at a minimum the site would contain water, power, communications and sewer at varying locations, particularly within road easements and surrounding residential lots.</p> <p>A number of Telstra pits were observed within the site during the inspection that potentially contained asbestos cement (see Photograph 18 of Appendix B).</p>

Photograph 18: a Telstra telecommunications pit potentially containing asbestos cement observed within public space within the alignment

- > A hazardous building material survey should be undertaken prior to the demolition of any buildings and structures within the site. Underground utilities such as water mains and Telstra pits may contain asbestos cement and should be identified and removed in accordance with regulatory guidance prior to and/or during construction of the project.

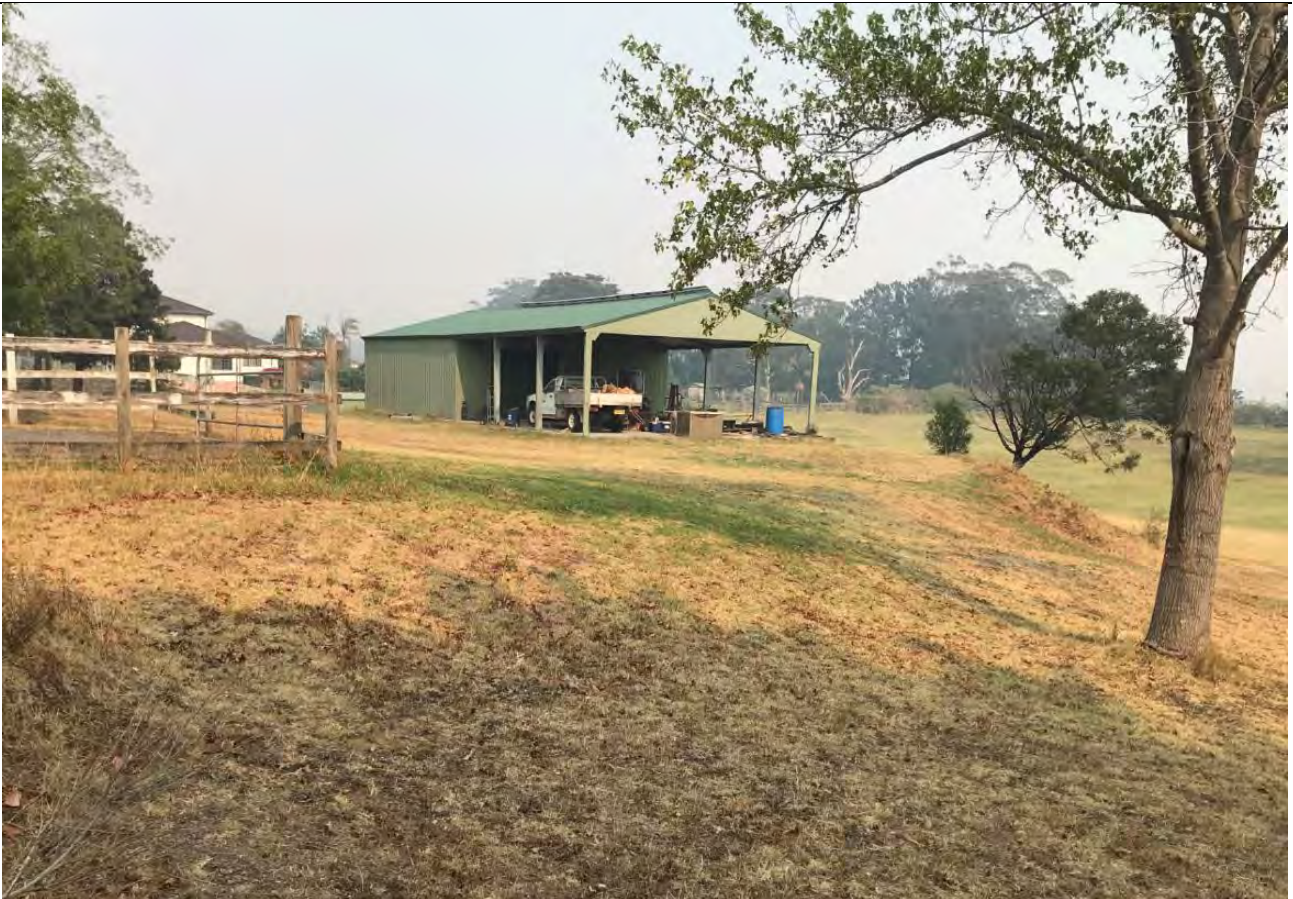
Photograph 19: an agricultural shed constructed atop a fill platform within Lot 24 / DP1138317 (AEC05)

Fill Areas (AEC05)	Two areas of obvious filling were observed during the site walkover within vacant Lot 1 / DP 1119325 and Lot 24 / DP1138317. The nature of the fill material was unable to be assessed due to a dense grass cover.	<ul style="list-style-type: none"> > OPP; > PCBs; and > Asbestos
Landscape Supplies Activities (AEC06)	Albion Park Landscaping Supplies occupies Lot 1 / DP714125. The current commercial operations are situated north of the site, however, a portion of vacant land that has historically contained a large stockpile and equipment is within the site. Current and historical commercial operations may have included storage of potentially contaminated materials.	
Potential Coal Tar Asphalt Pavement (AEC07)	There is potential for existing remnant asphalt pavement within the site to contain coal tar. This includes pavement within Terry Street, Tripoli Way, The Expressway, Moles Street, Calderwood Road and the Illawarra Highway.	<ul style="list-style-type: none"> > Phenol; and > PAH

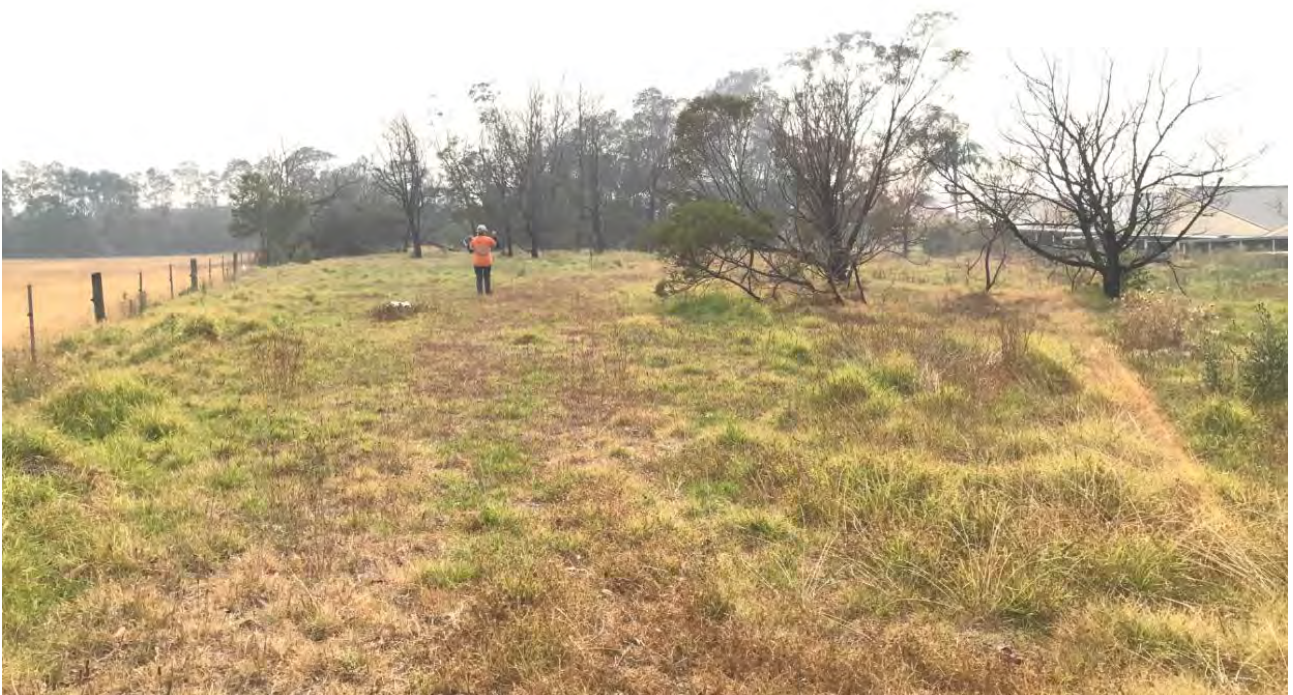
Photograph 20: a vacant parcel of land east of Hamilton Road in Lot 1 / DP1119325, with evidence of filling visible throughout (AEC05), looking east

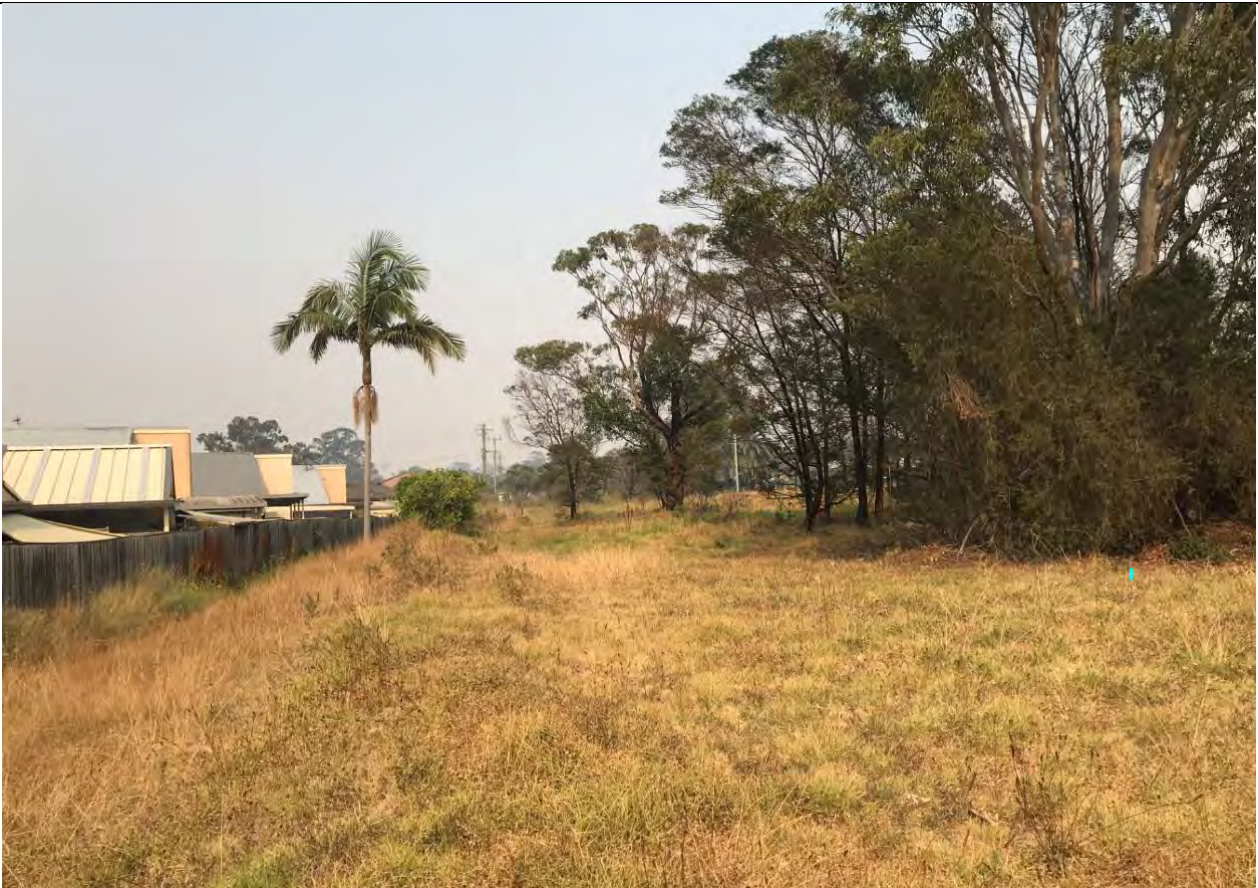
Photograph 21: a vacant parcel of land east of Hamilton Road in Lot 1 / DP1119325, with evidence of filling visible throughout (AEC05), looking west

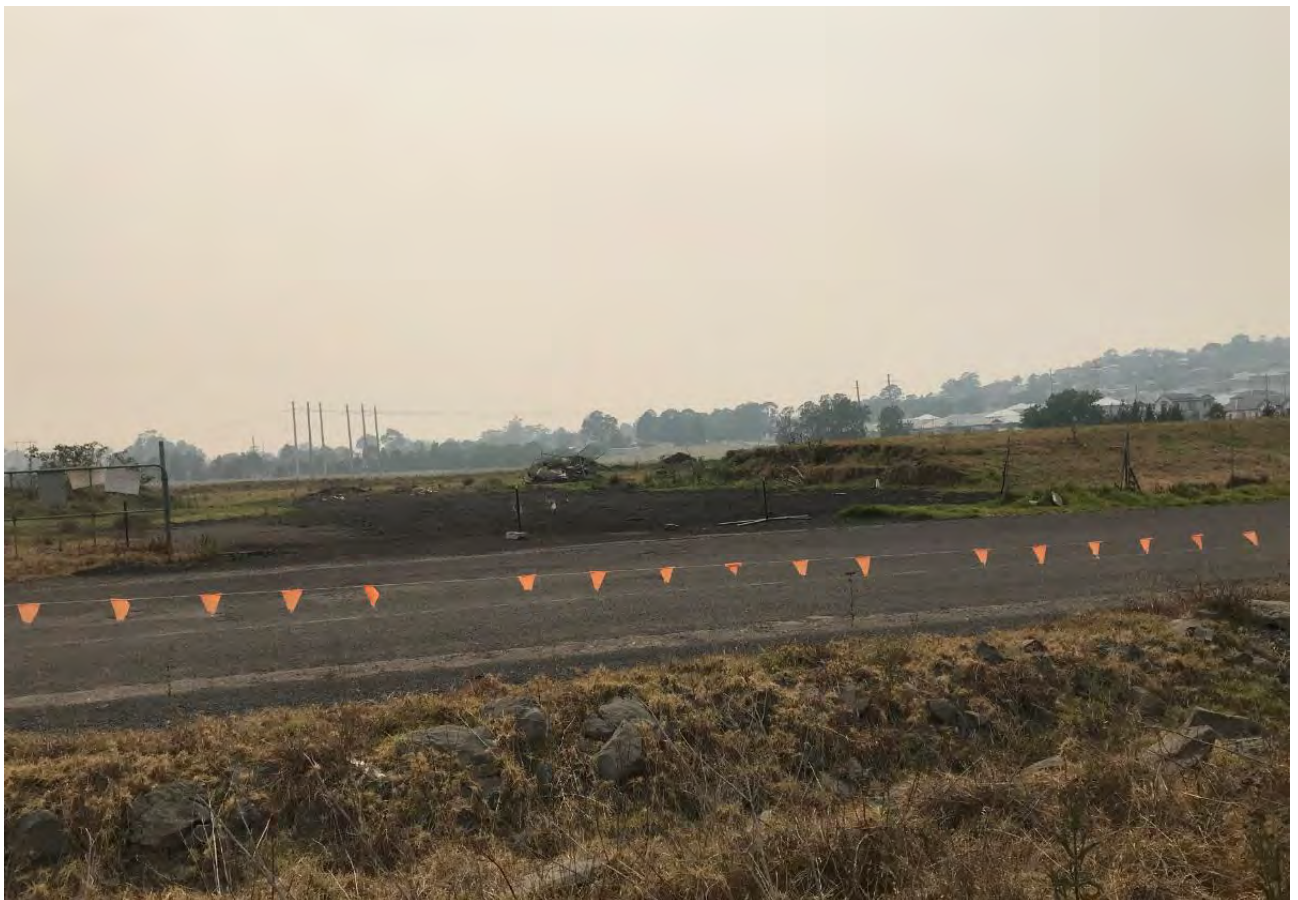
Photograph 26: the construction laydown and stockpiling area in the far western extremity of the site within Lot 1182 in DP1202087

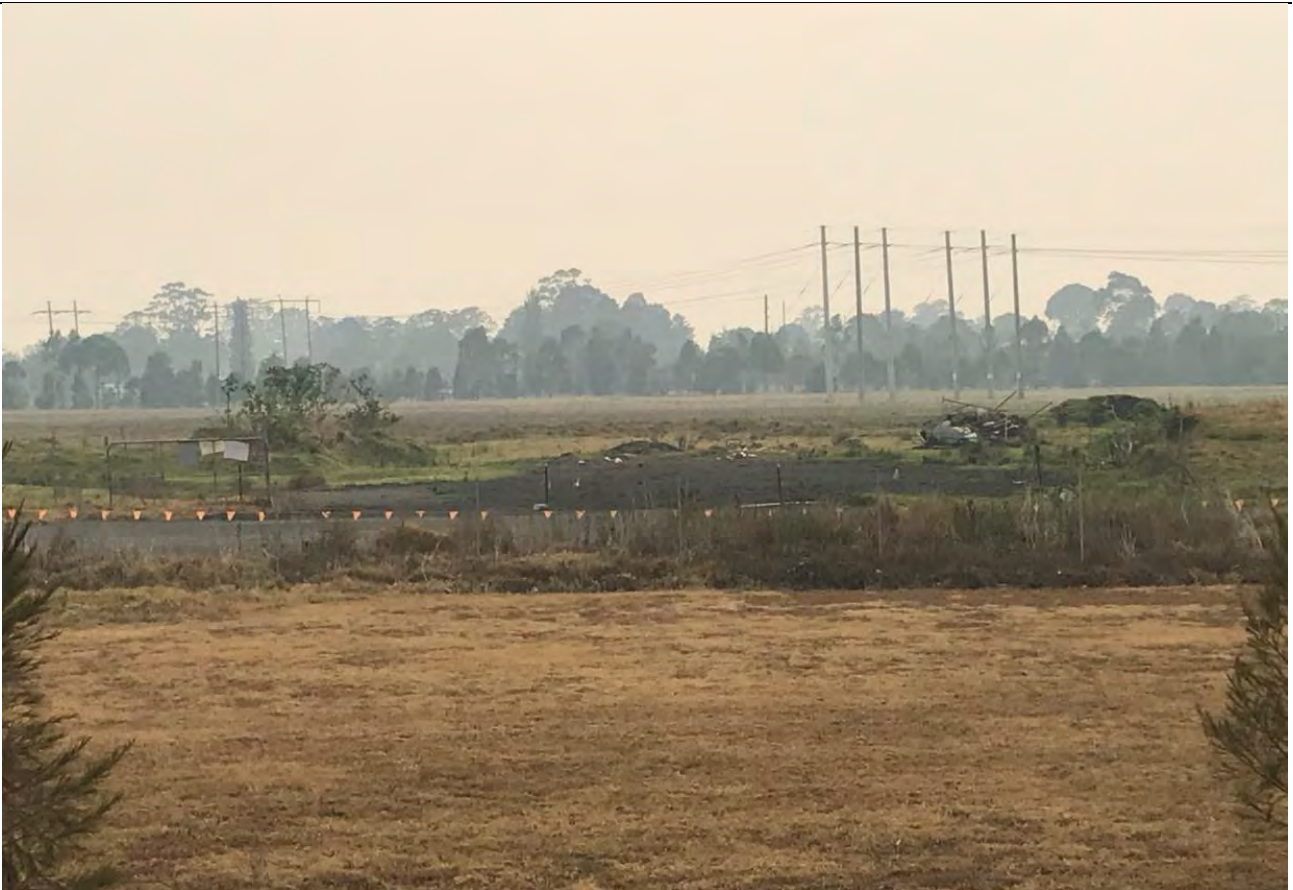
Photograph 27: the construction laydown and stockpiling area in the far western extremity of the site within Lot 1182 in DP1202087
