Tripoli Way Extension,
Albion Park NSW

APPENDIX

GEOLOGICAL LOGS

HISTORICAL AERIAL PHOTOGRAPHS

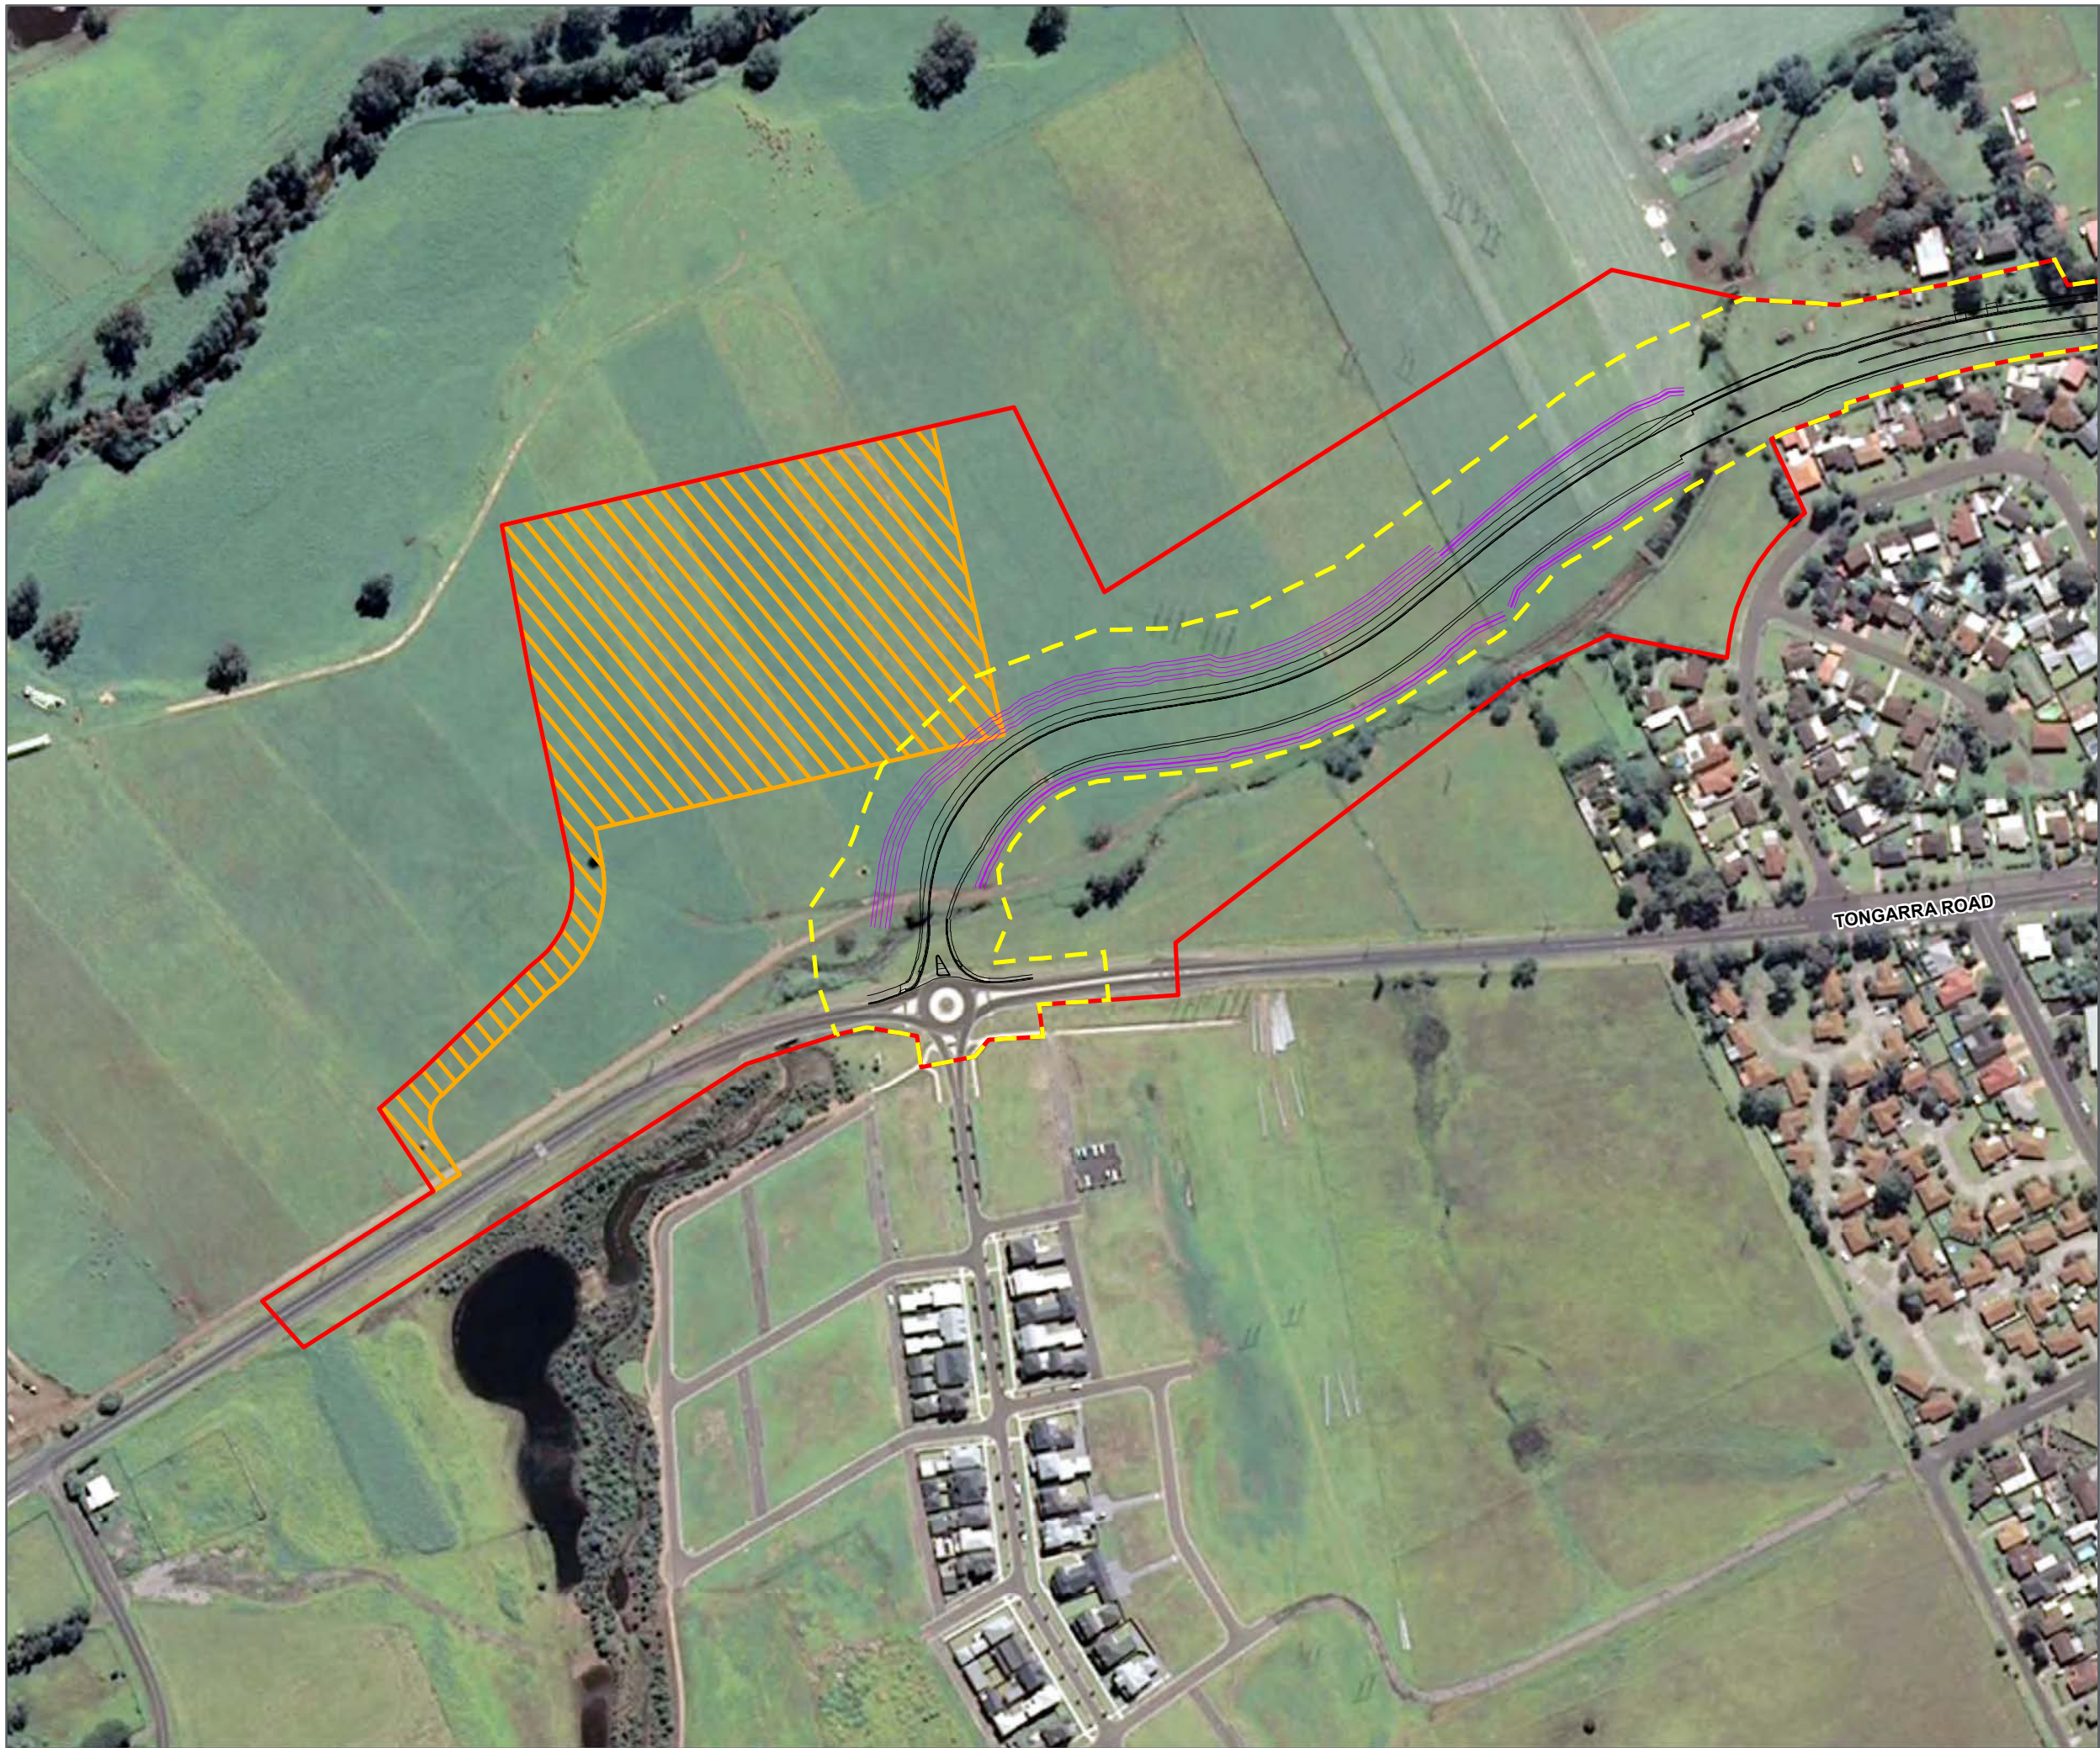
Aerial Imagery: 2008

- Study Area (20.20 ha)
- Proposed Road Alignment
- Proposed Stormwater Network
- Construction Footprint (14.47 ha)
- Potential Ancillary Facility

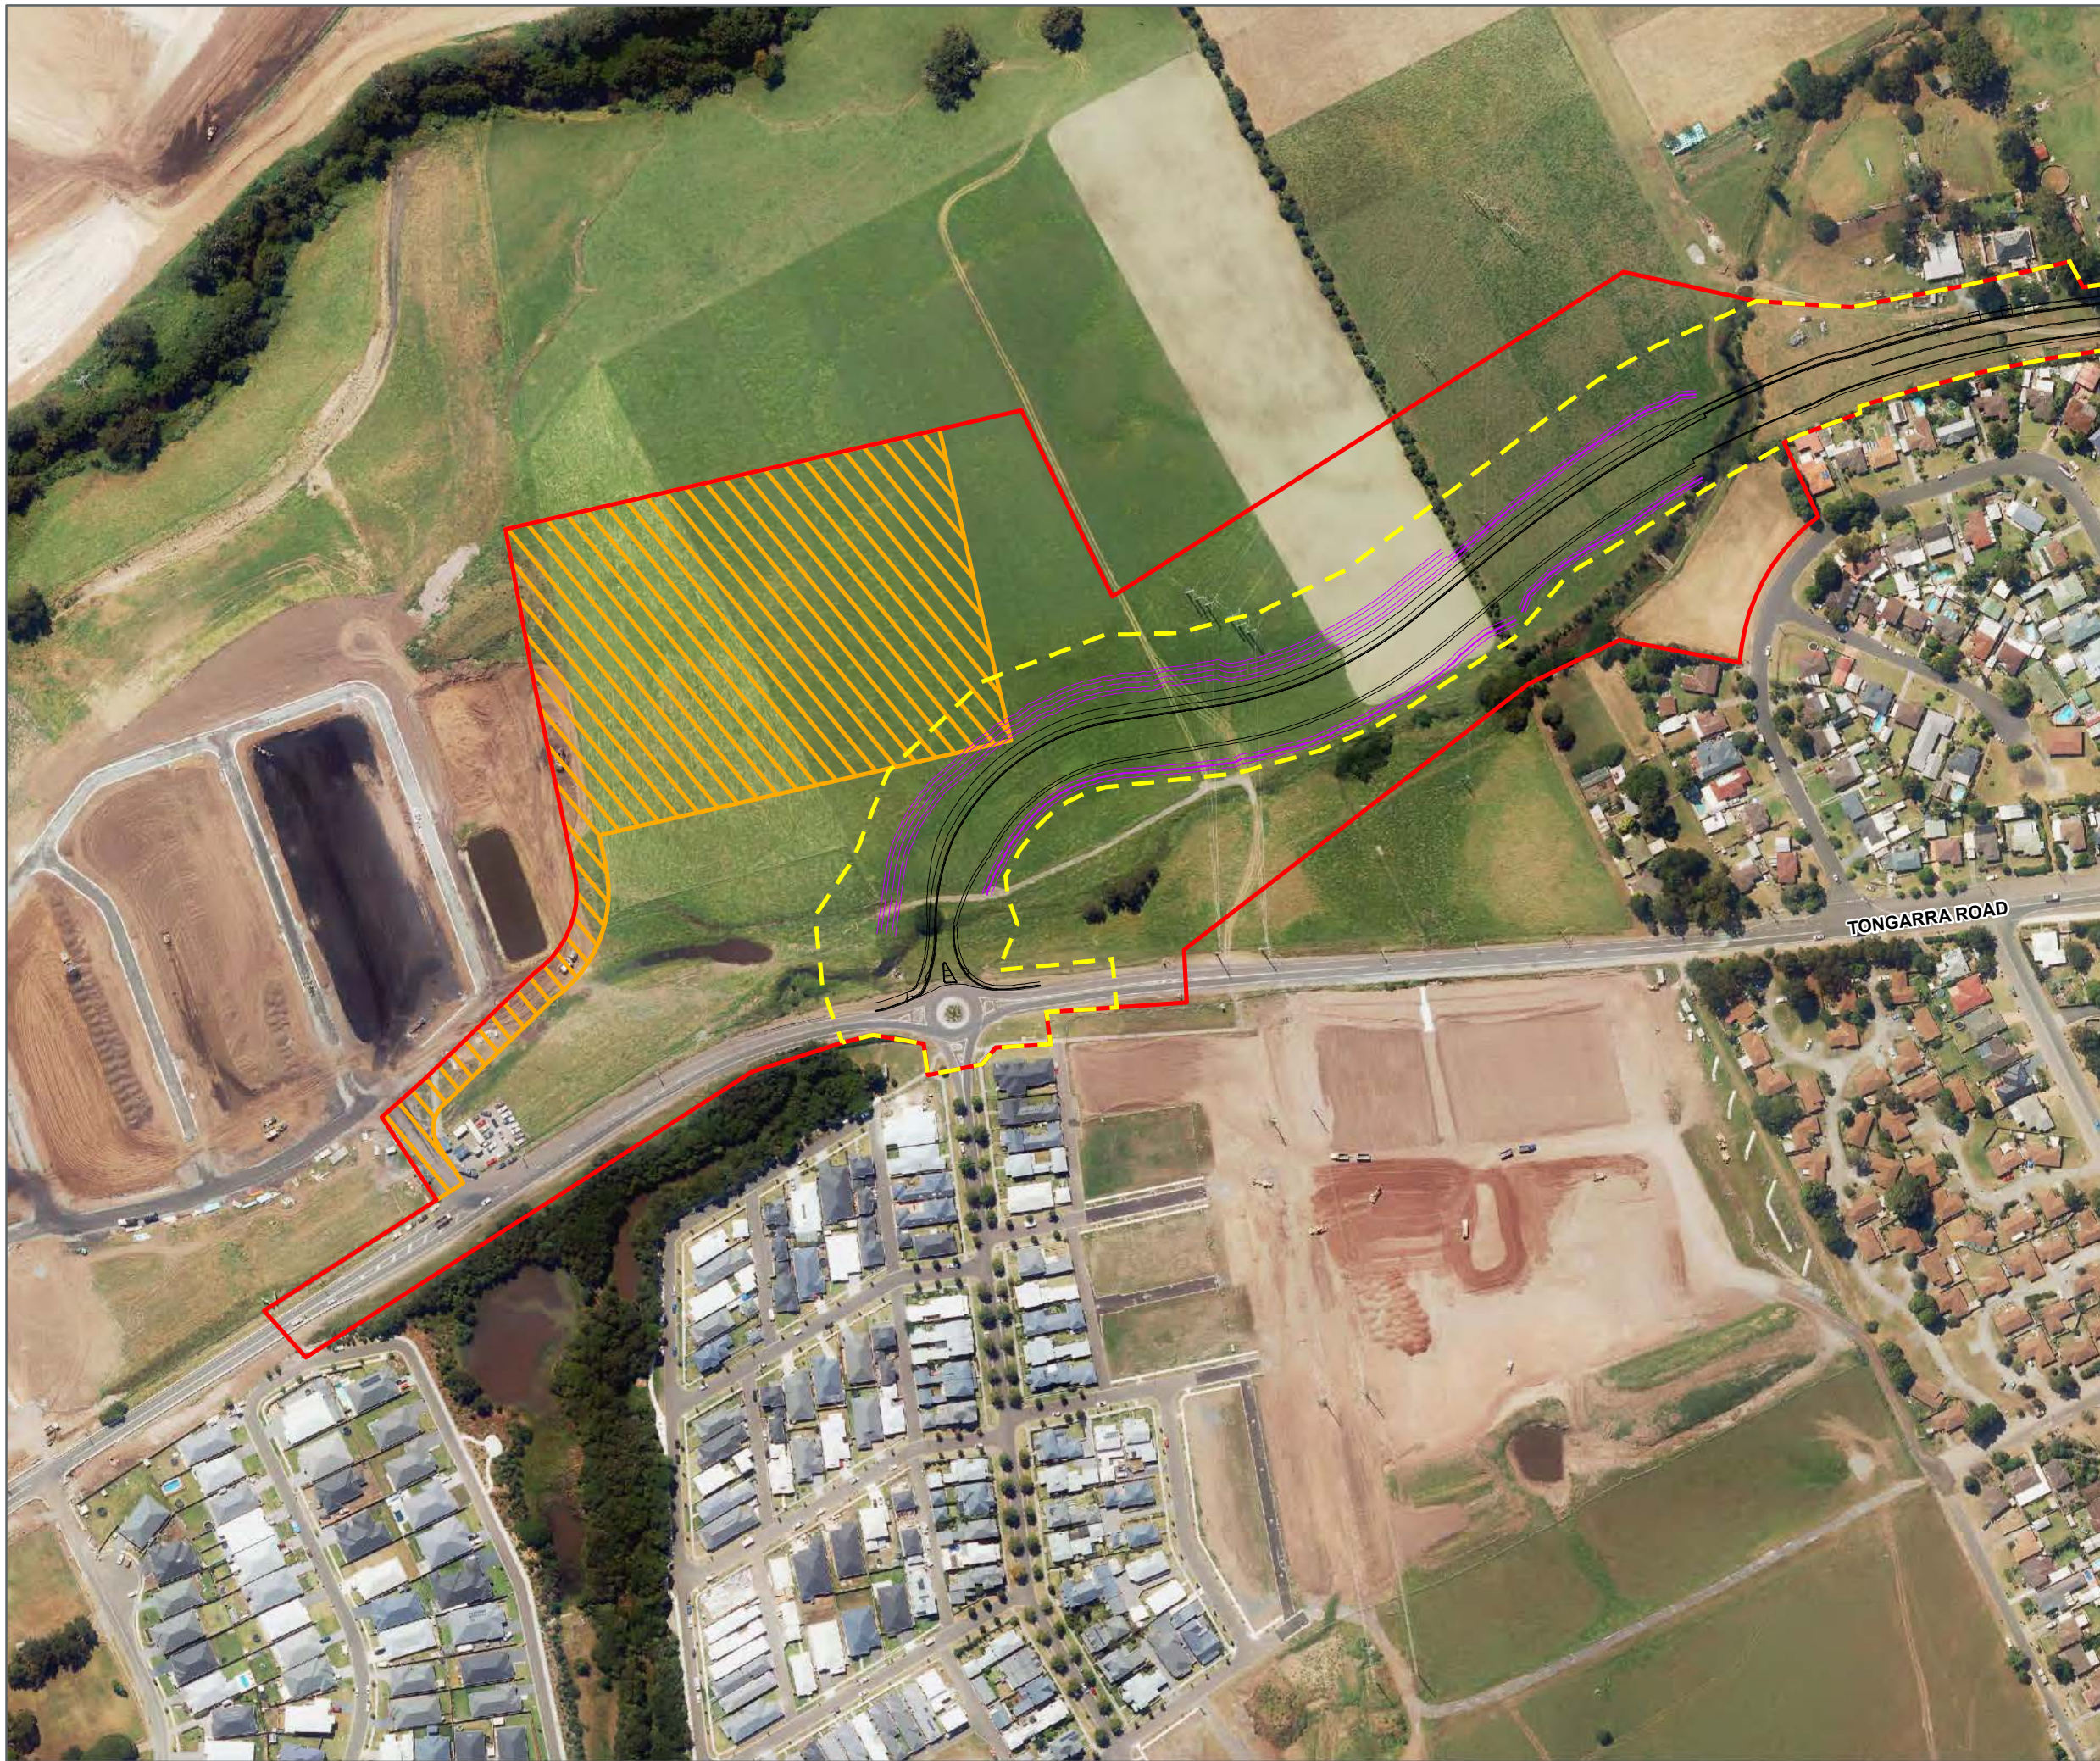
Aerial Imagery: 2016

- Study Area (20.20 ha)
- Proposed Road Alignment
- Proposed Stormwater Network
- Construction Footprint (14.47 ha)
- Potential Ancillary Facility
