# Information Synthesis Report

## Lake Illawarra

June 2019

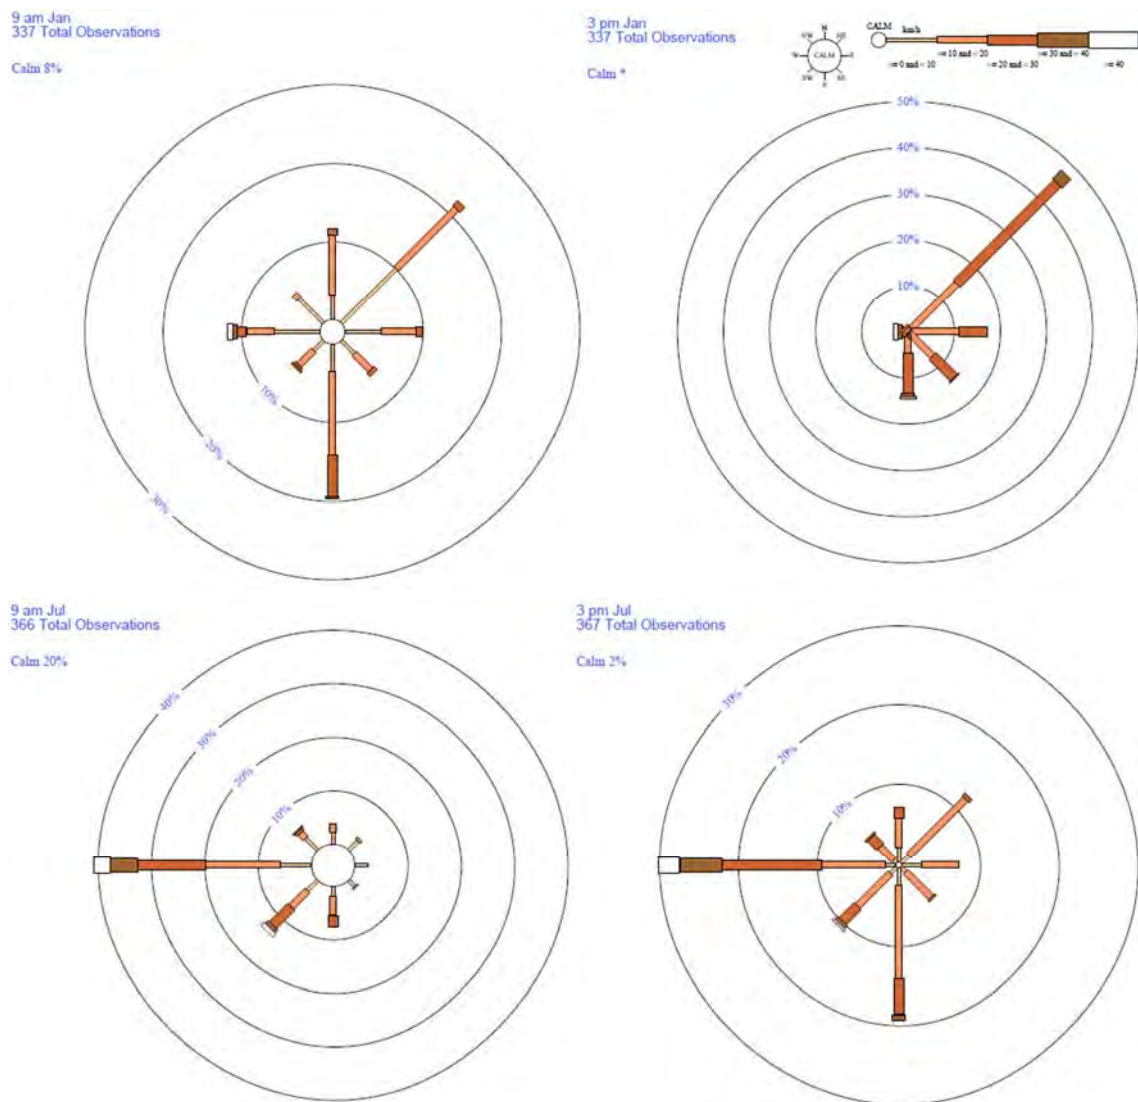
Figure 2-2 Wind Rose for Wollongong Airport, showing average 9am (left) and 3pm (right) conditions for January (top) and July (bottom) (source: BoM)

**Wind** typically blows from the northeast and south during the summer months with northeast winds dominating afternoon conditions (see Figure 2-2). In winter, westerly winds dominate, with south and south-westerly winds also common (see Figure 2-2). Average wind speeds through summer and winter are similar, ranging between around 10 - 20 km/hr (see Figure 2-2). Velocities can reach up to 45 - 55 km/hr throughout the year, with greater velocities experienced during east coast low weather events (WBM, 2003).

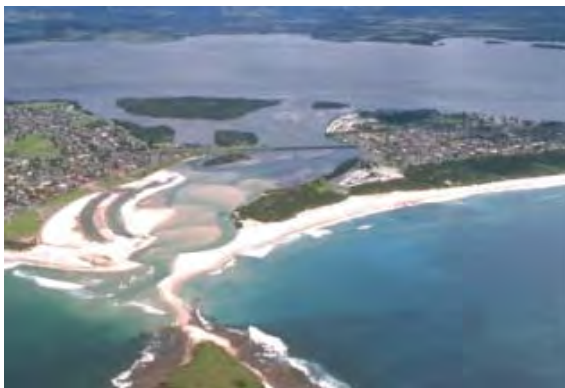
*2000: natural entrance, with varying opening position south or north of Windang Island*

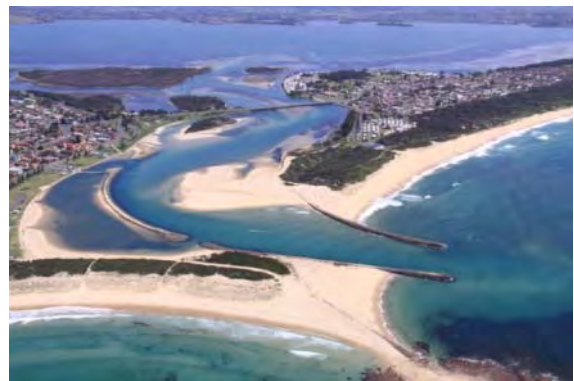
*2009: trained entrance, with twin breakwaters and southern training wall fixing the entrance opening position.*

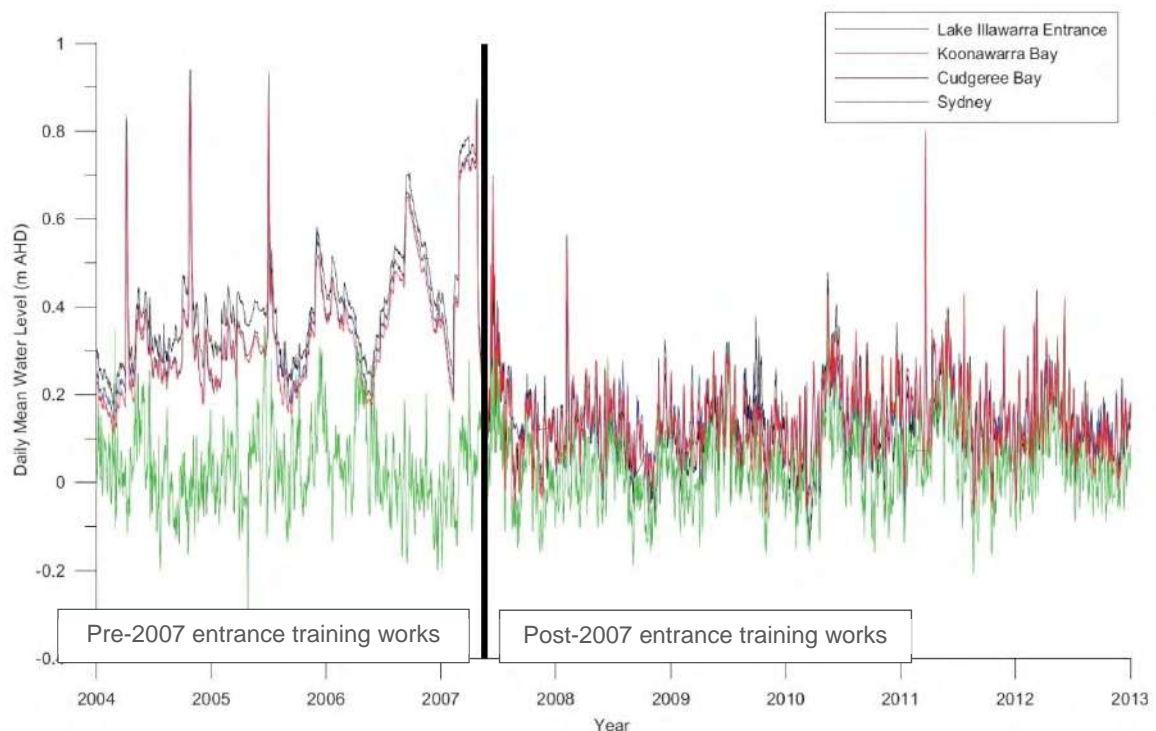
**Figure 2-9 Daily water levels within the Lake, pre-and post-entrance training, relative to Sydney Ocean Tide levels (Source: MHL, 2013)**

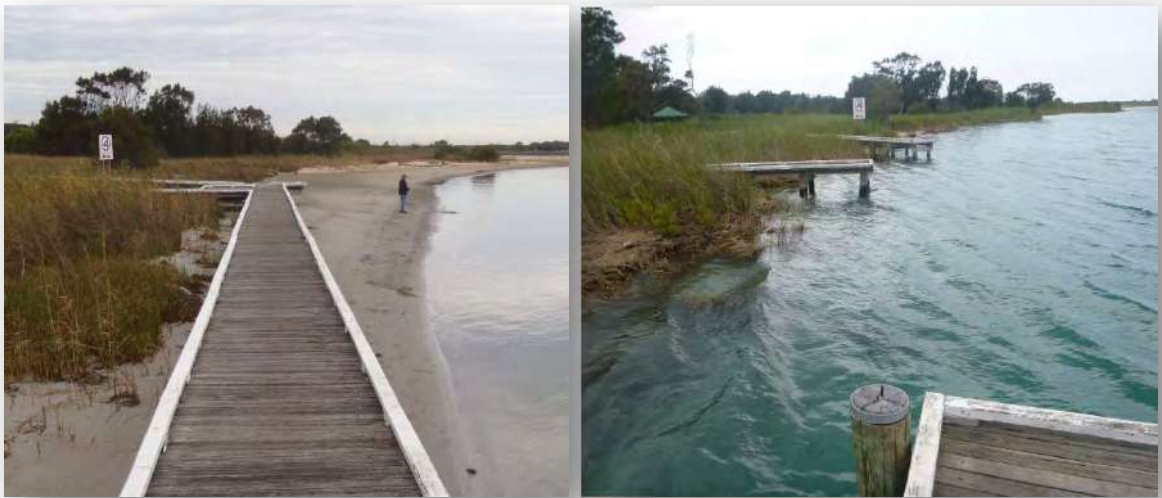
**Figure 2-11 Damage to sections of the boardwalk downstream of Windang Bridge, showing sections of a boardwalk that have been removed due to piles being undermined from tidal scour (2012 -2015) (Source Wiecek et al., 2016)**

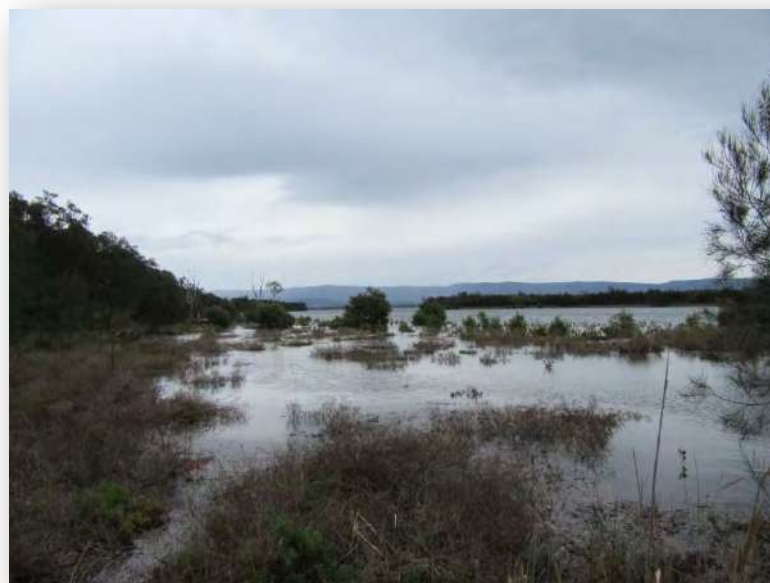
**Figure 2-12 Mangrove saplings establishing in Lake Illawarra viewed from Pelican View Reserve**

- Lake water levels are now directly driven by the ocean tides due to the training works. This has resulted in impacts on estuarine vegetation, which are continuing to adjust to an increasing tidal range. Mangroves have begun to flourish in some areas (see Wiecek et al., 2016). An example of the increase in mangroves is shown in Figure 2-12.

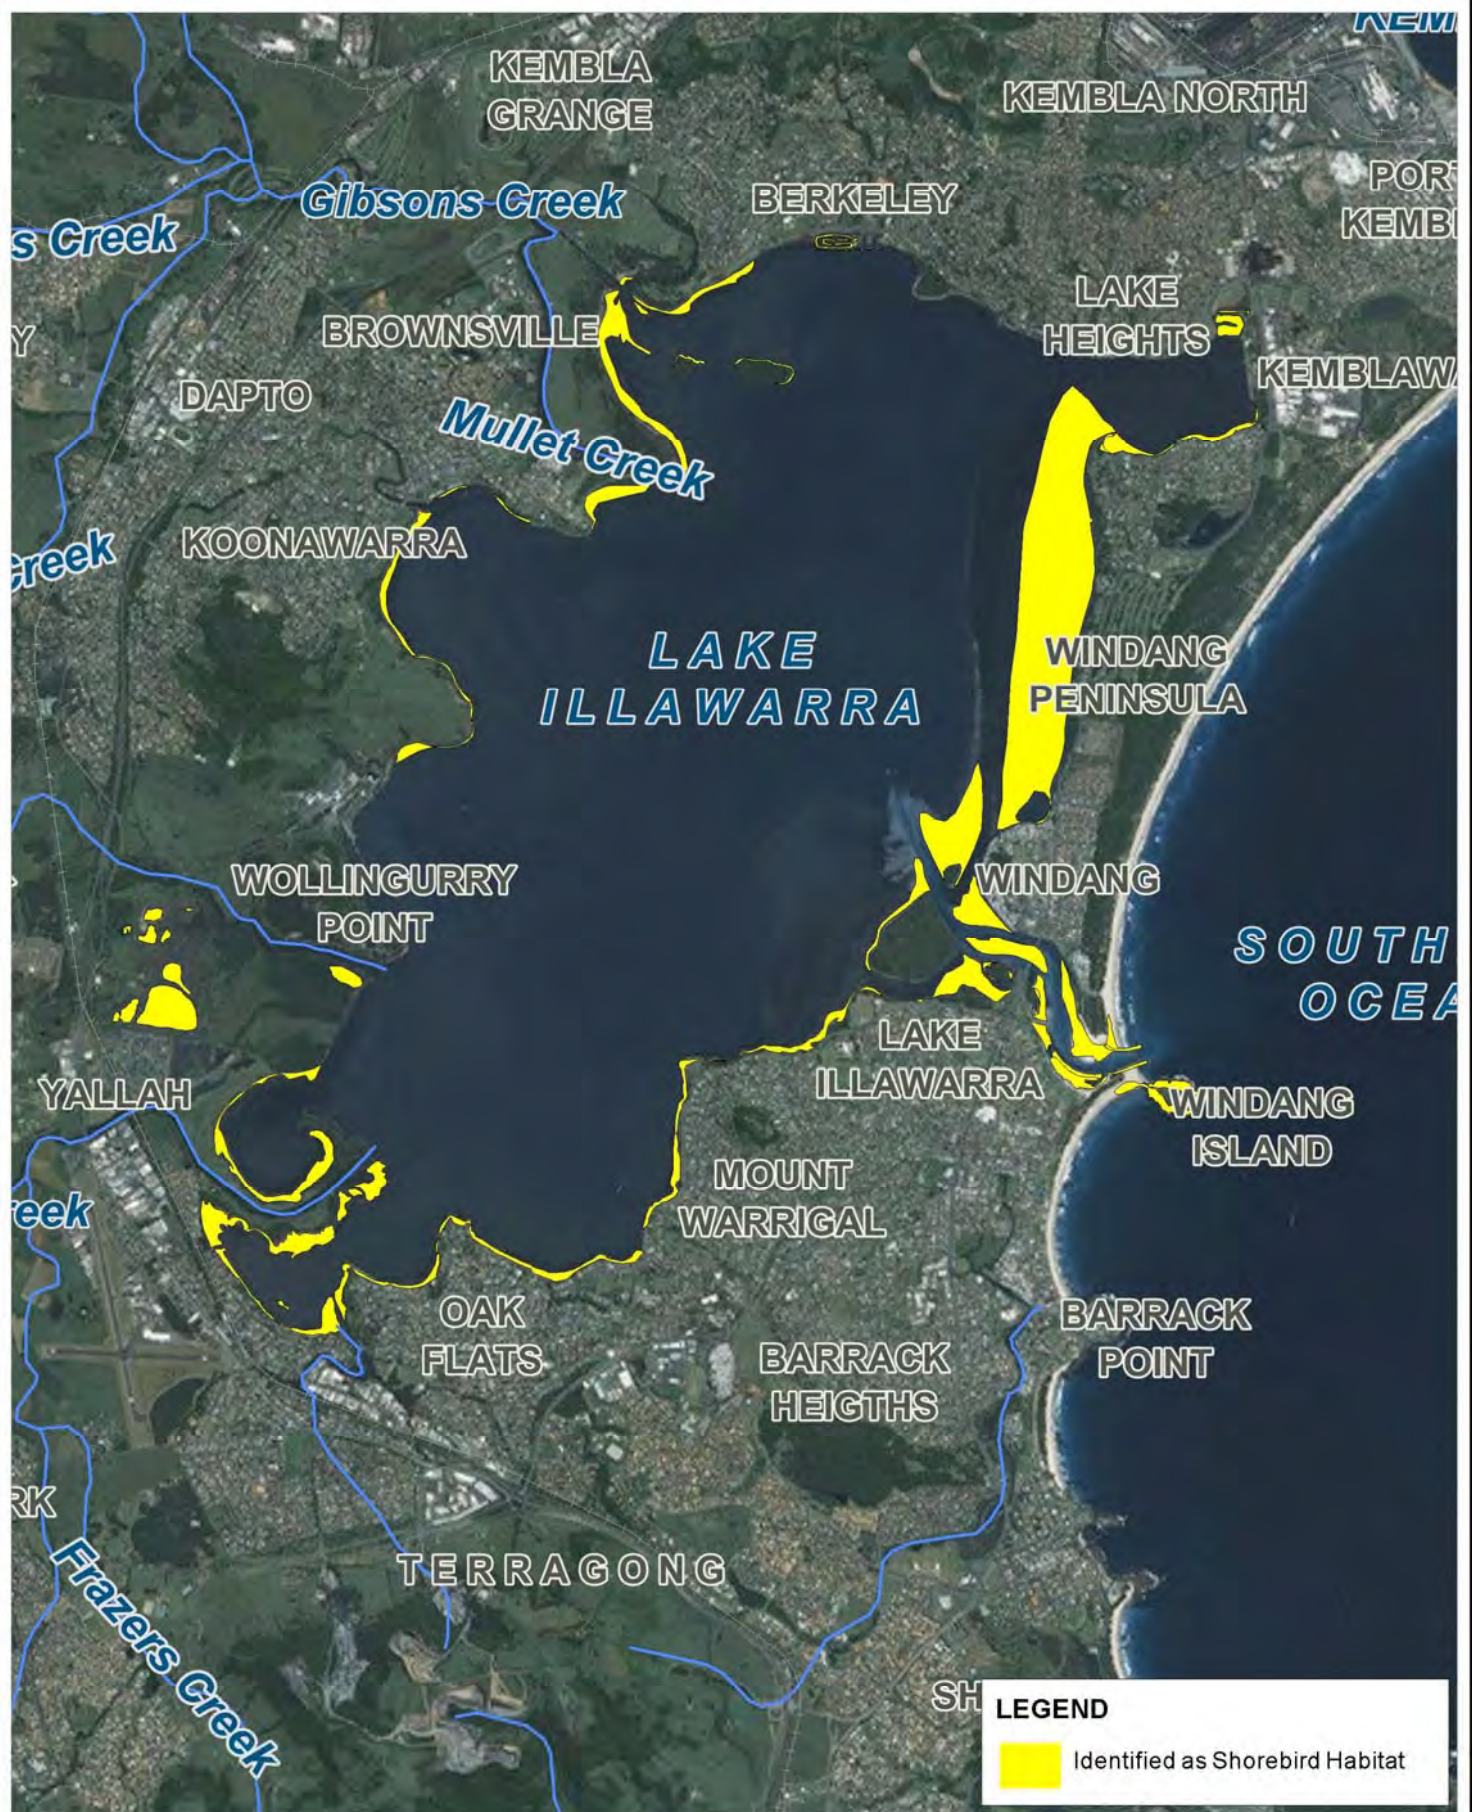
Figure:  
**2-21**

Title:  
**Identified Shorebird Habitat**

A shorebird habitat and mapping exercise was undertaken by NPWS in 2009, reproduced in Figure 2-21. This information provides a baseline and should be viewed with caution given the extent of change occurring since that time. Mudflats accounted for the largest area of shorebird habitat, comprising 270.21 ha (75.0% of total assessed shorebird habitat area). Saltmarshes accounted for the second largest area of shorebird habitat, comprising of 29.90 ha (8.3% of total assessed shorebird habitat area). Sandflats, located at the Lake's entrance, comprised of 22.37 ha (6.2% of total assessed shorebird habitat area). The remaining 37.77 ha (10.5%) of shorebird habitat comprised of brackish (13.67 ha) and freshwater (10.71 ha) swamps, bushlands (2.78 ha), and naturally formed (5.37 ha) and artificial (2.82 ha) rocky shores.

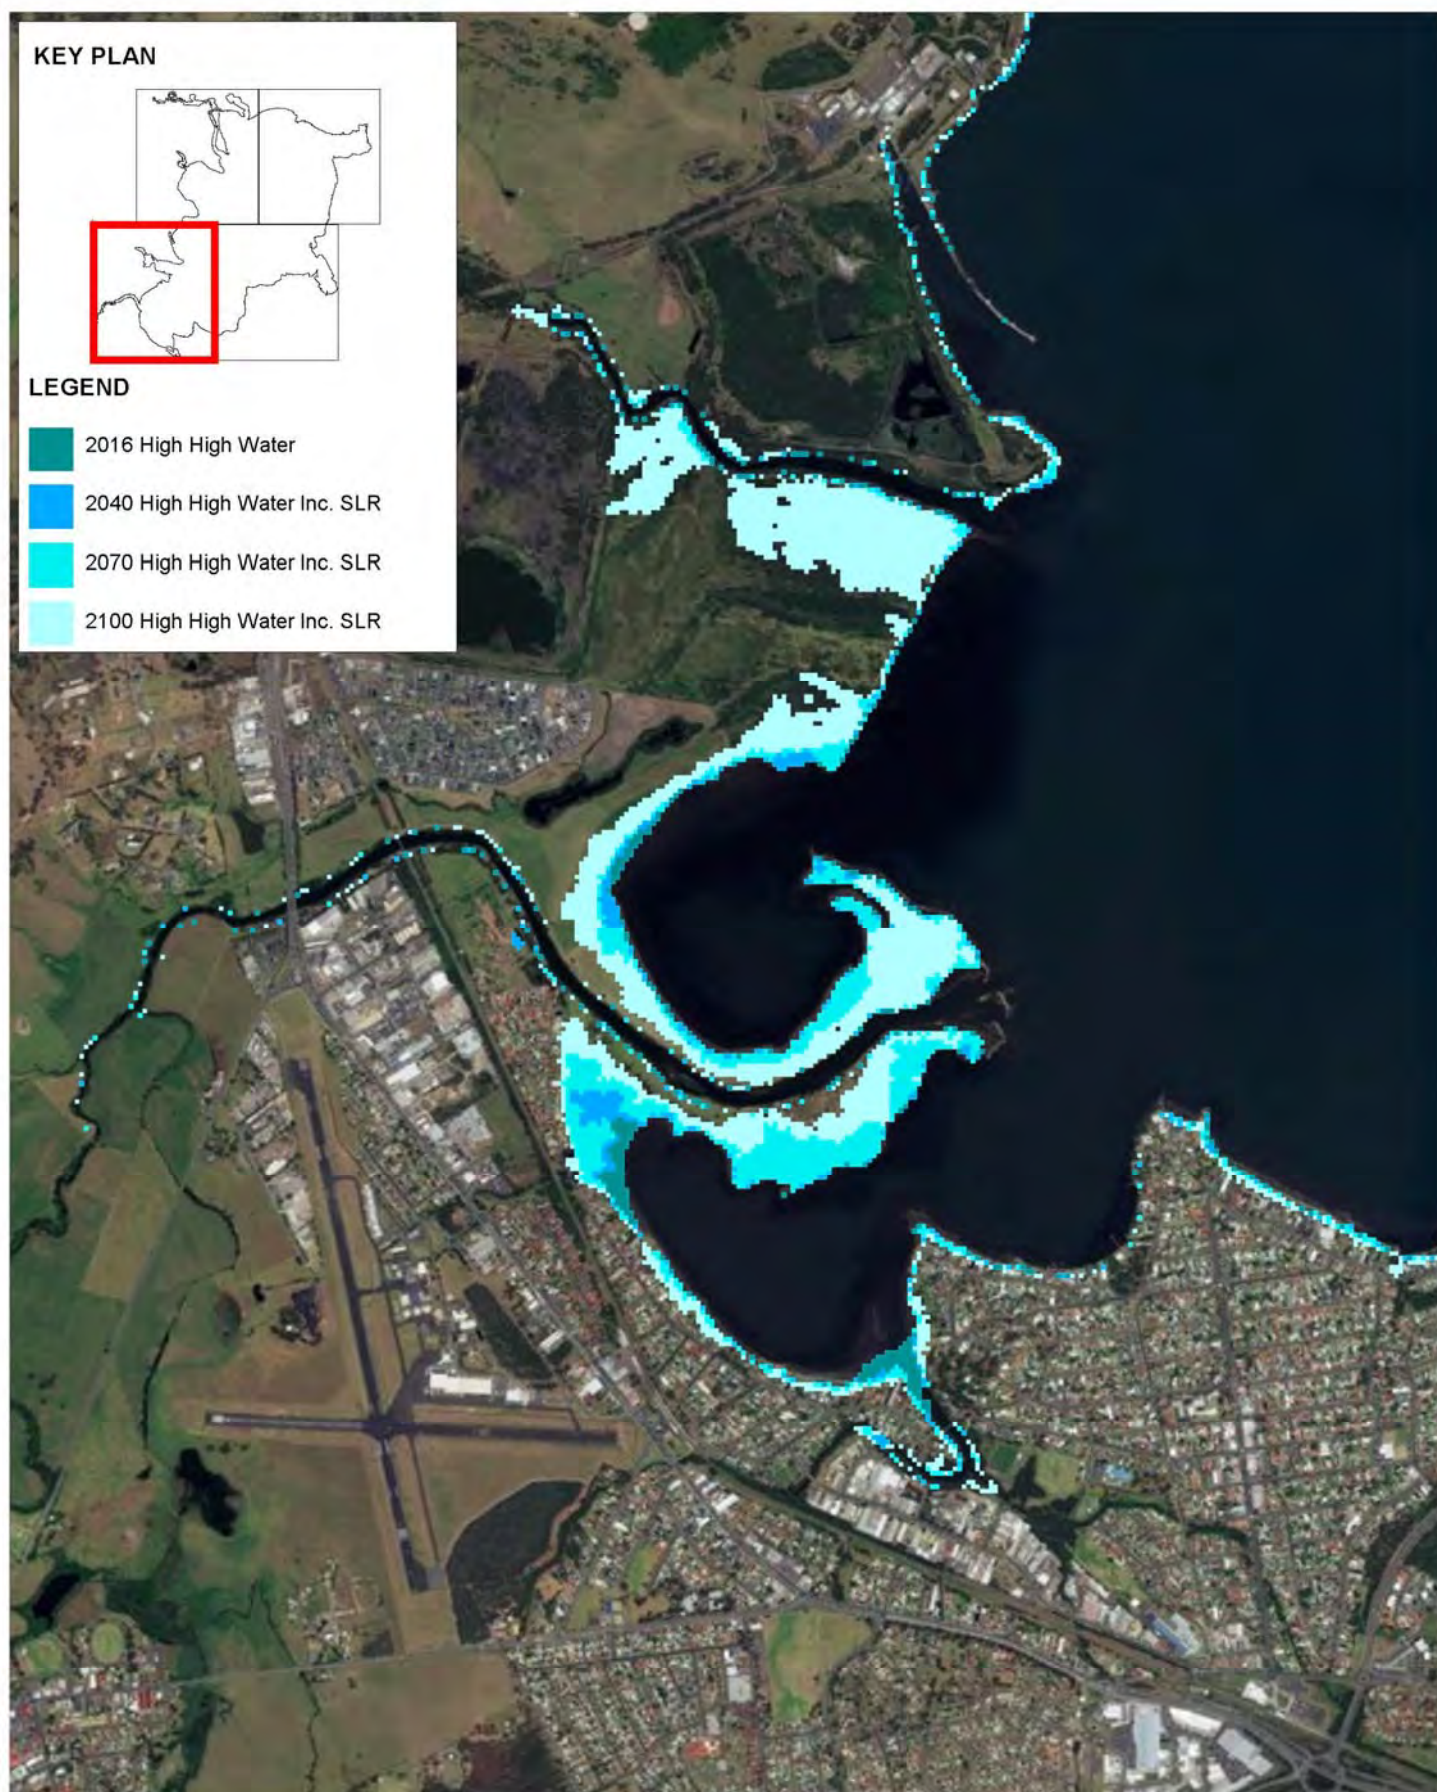
Figure:  
**2-34**

Title:  
**Tidal Inundation Model Extents for 2016, 2040,  
2070 and 2100**

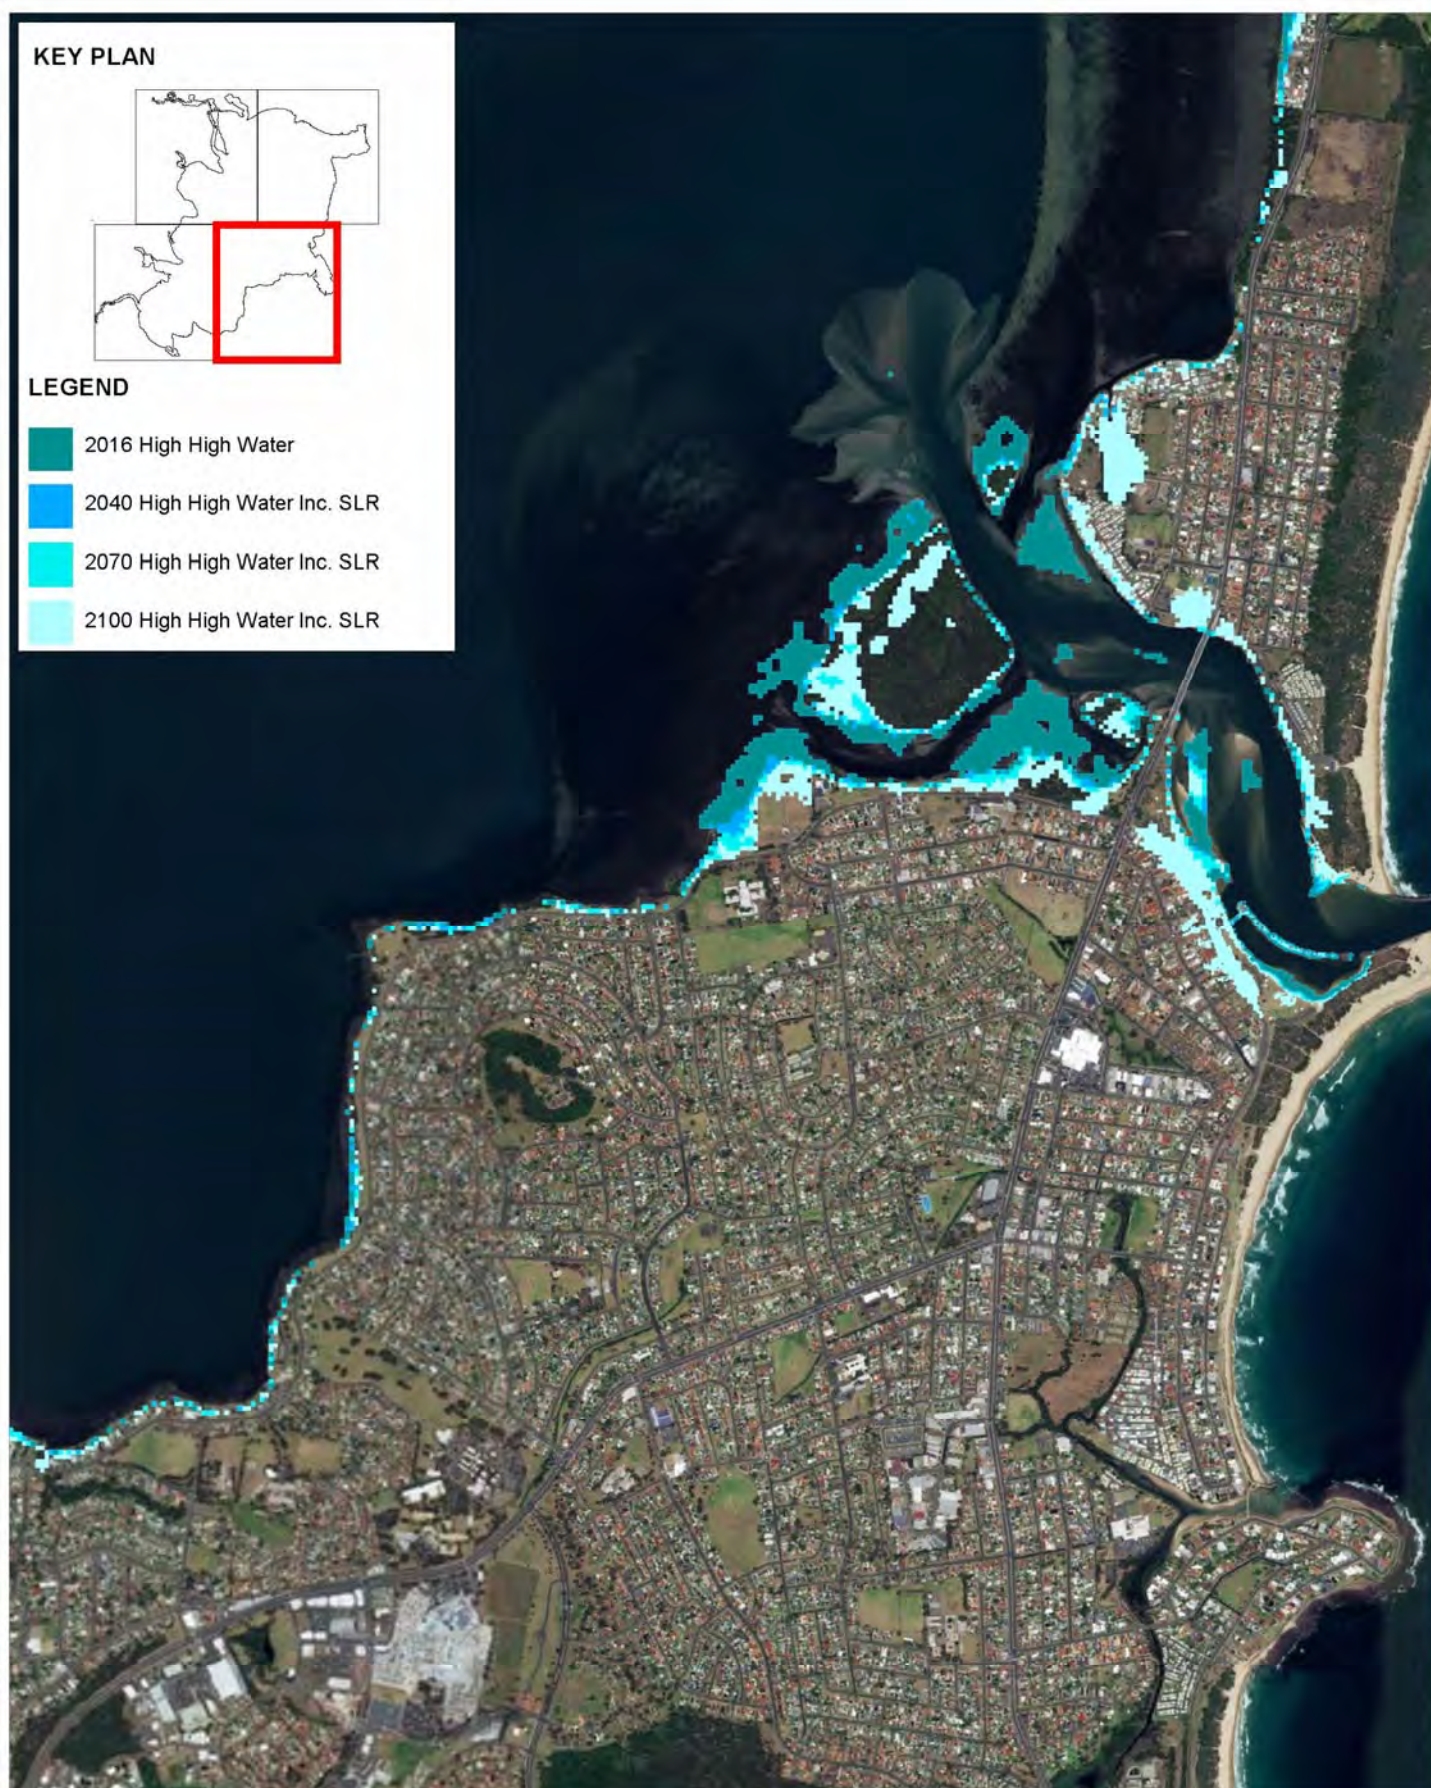
Figure:  
**2-35**

Title:  
**Tidal Inundation Model Extents for 2016, 2040,  
2070 and 2100**

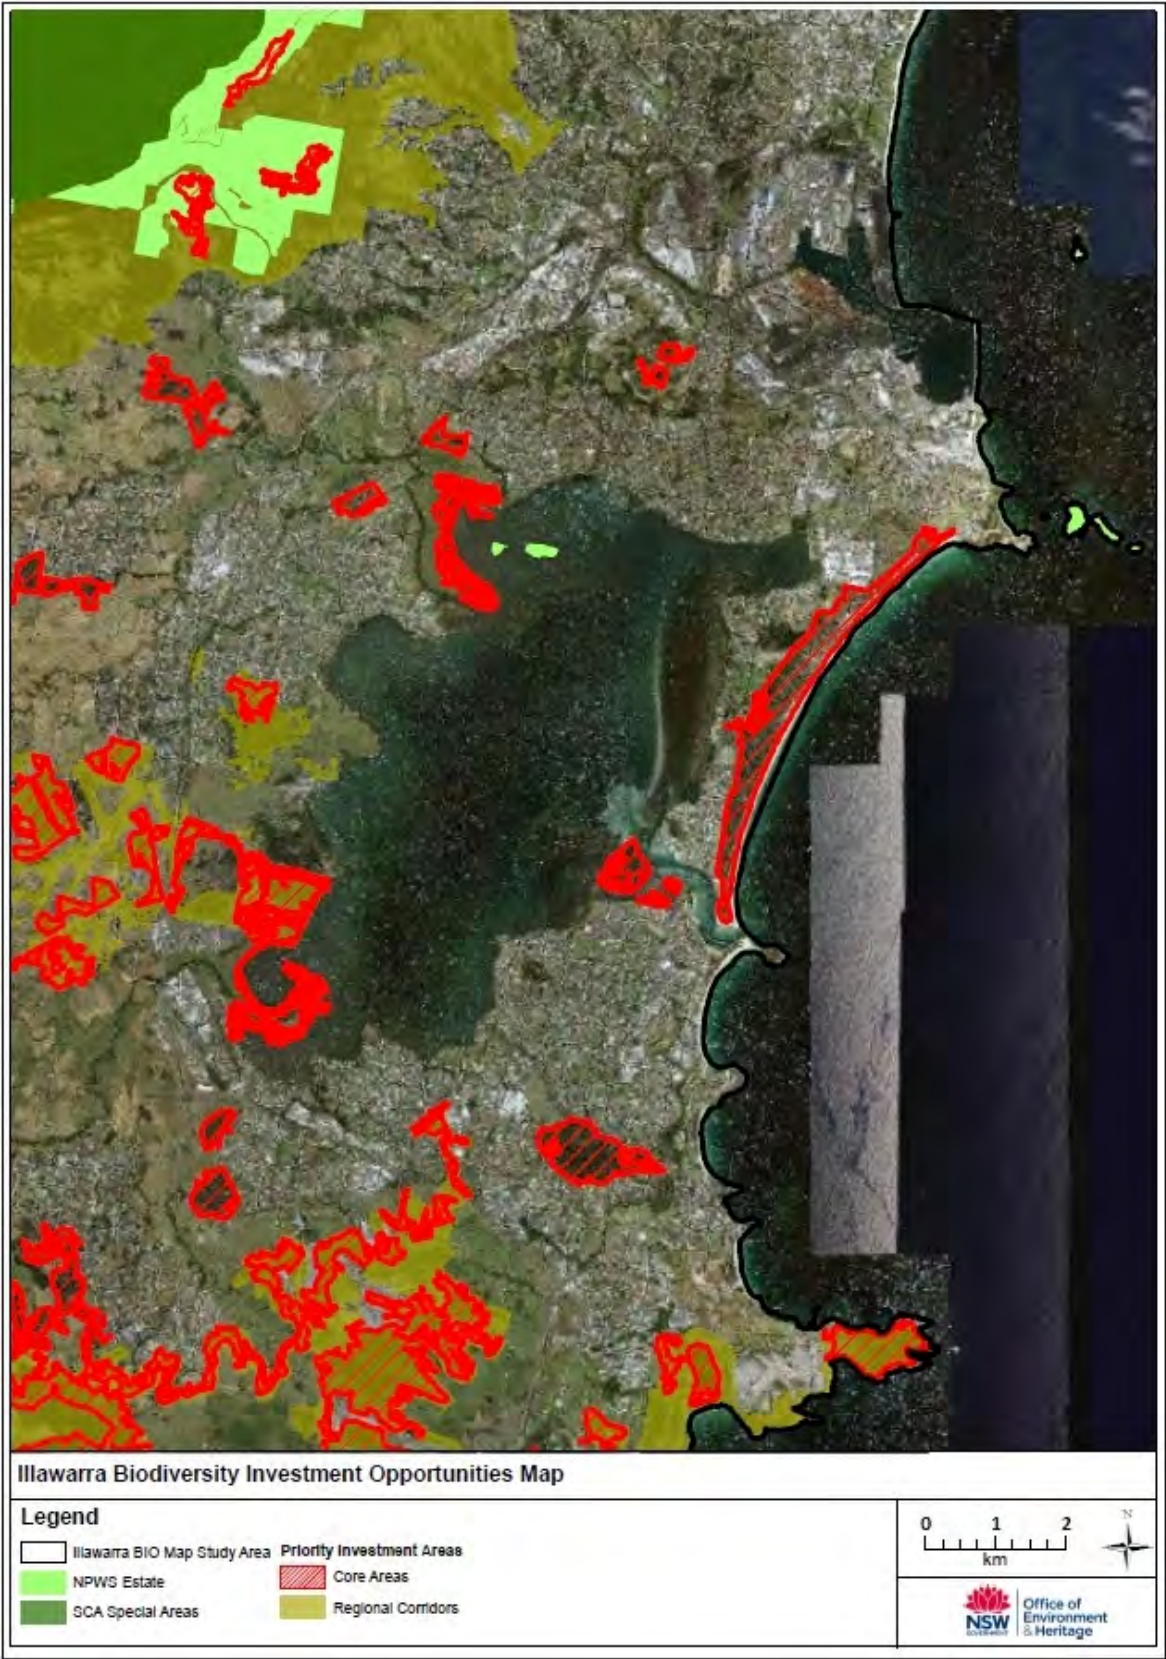
Figure 3-3 Illawarra BIO Map priority investment areas in and around Lake Illawarra

An extract of the mapping is shown in Figure 3-3. This indicates that there are some areas mapped as 'core areas' and 'regional corridors' in and around Lake Illawarra highlighting that the Lake supports large areas of high conservation value. These areas should be considered in the CMP in terms of management actions to enhance their protection and rehabilitation. These sites would therefore have increased opportunities to access funding.

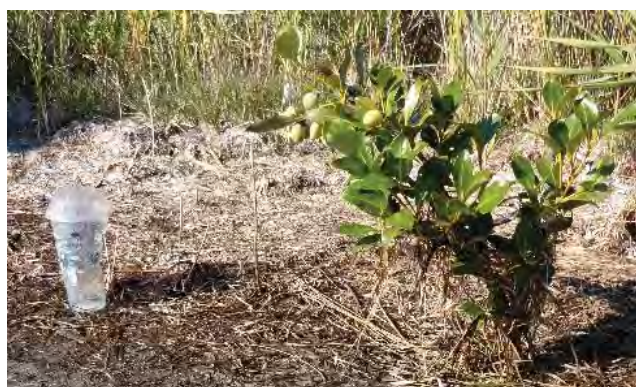
**Figure 1: Propagules growing on a young mangrove less than 50cm in height from Lake Illawarra (D. Wiecek, OEH 17-5-17).**

*A. marina*, like many other plant species is dioecious, meaning an individual tree can fertilise its own flowers. While still on the tree the seeds evolve into a “propagule”, i.e., they develop primary leaves and root structure, that once released from the tree can quickly grow into saplings on suitable substrate. Flower and seed production has been witnessed in trees as young as two (I. Yassini pers. comm., 2017) or three (S Paul, pers. comm. 2016) years of age and of limited stature (Figure 1). Hundreds of flowers will emerge in summer on a tree only two meters in height.

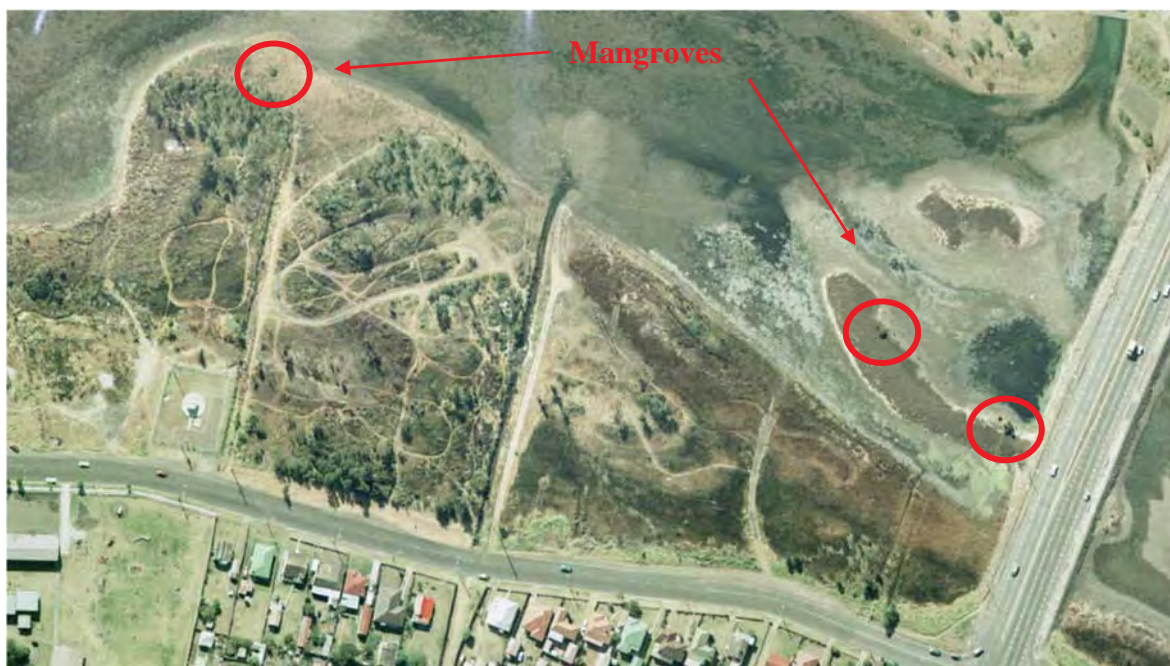
**Figure 2: Mangroves present in Lake Illawarra along the southern foreshore west of Windang Bridge visible in aerial photography from 1977.**

The larger mangroves reported by Yassini (1985) are clearly observable in aerial photographs taken in 1977 (Figures 2 and 3), with imagery from 1974 (Figure 4) also likely showing at least one of these mangroves. To be of an observable size in the photos, the mangroves would have been in place for a period of years prior, possibly establishing in the late 1960s or early 1970s.

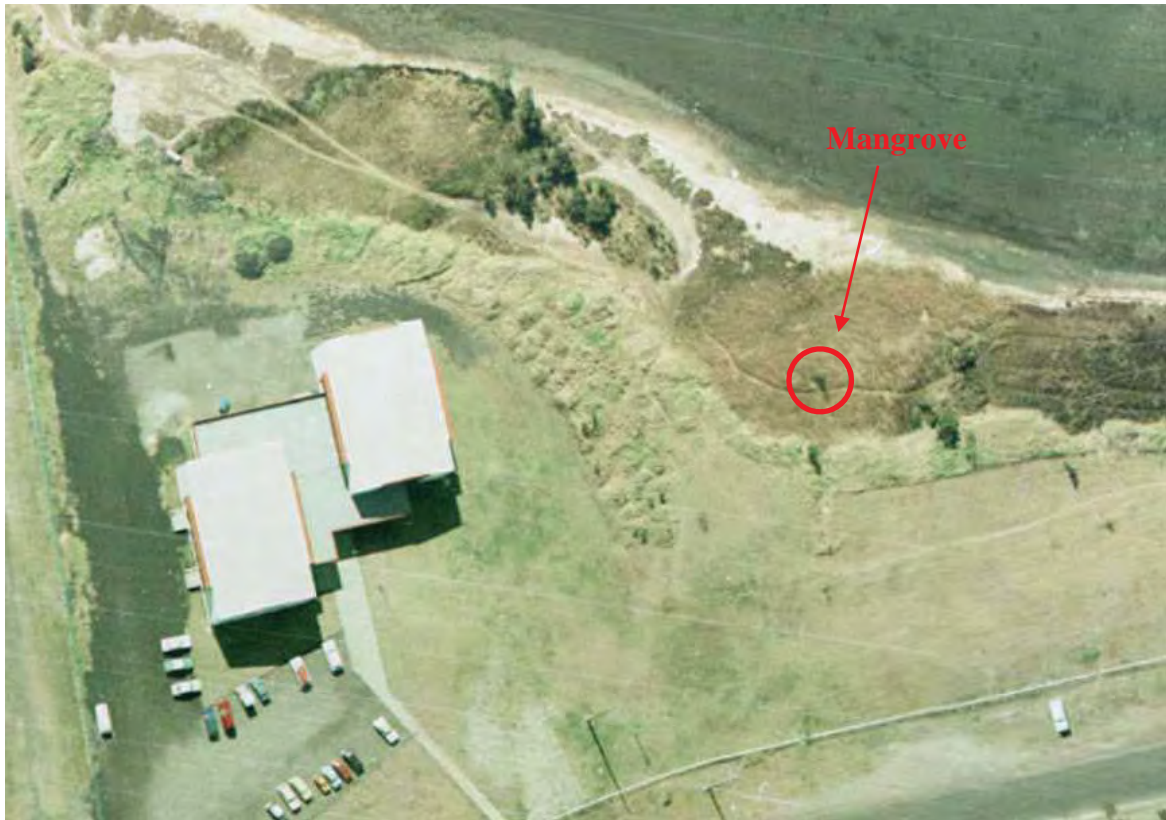
**Figure 3: Mangrove present in Lake Illawarra along the southern foreshore adjacent to the PCYC visible in aerial photography from 1977.**

The three other mangroves noted by Yassini (1985) further west of the jetty tree and adjacent to the PCYC, one of which is shown in Figure 3, are still at that location, and in April of 2017 were approximately 6 meters in height. It is conceivable that these trees were derived from propagules from those observed adjacent to Windang Bridge prior to the foreshore works.

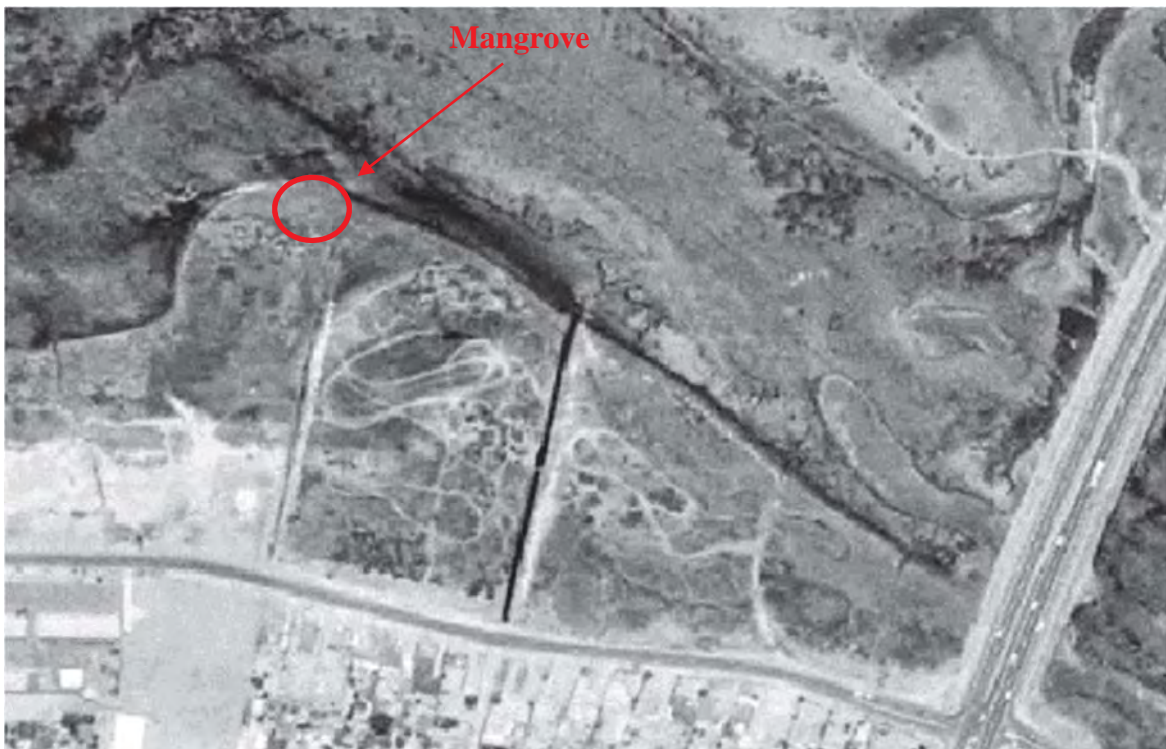
**Figure 4: Aerial image from 1974 of the southern foreshore immediately west of Windang Bridge that appears to show one of the mangroves visible in the 1977 aerial photography.**

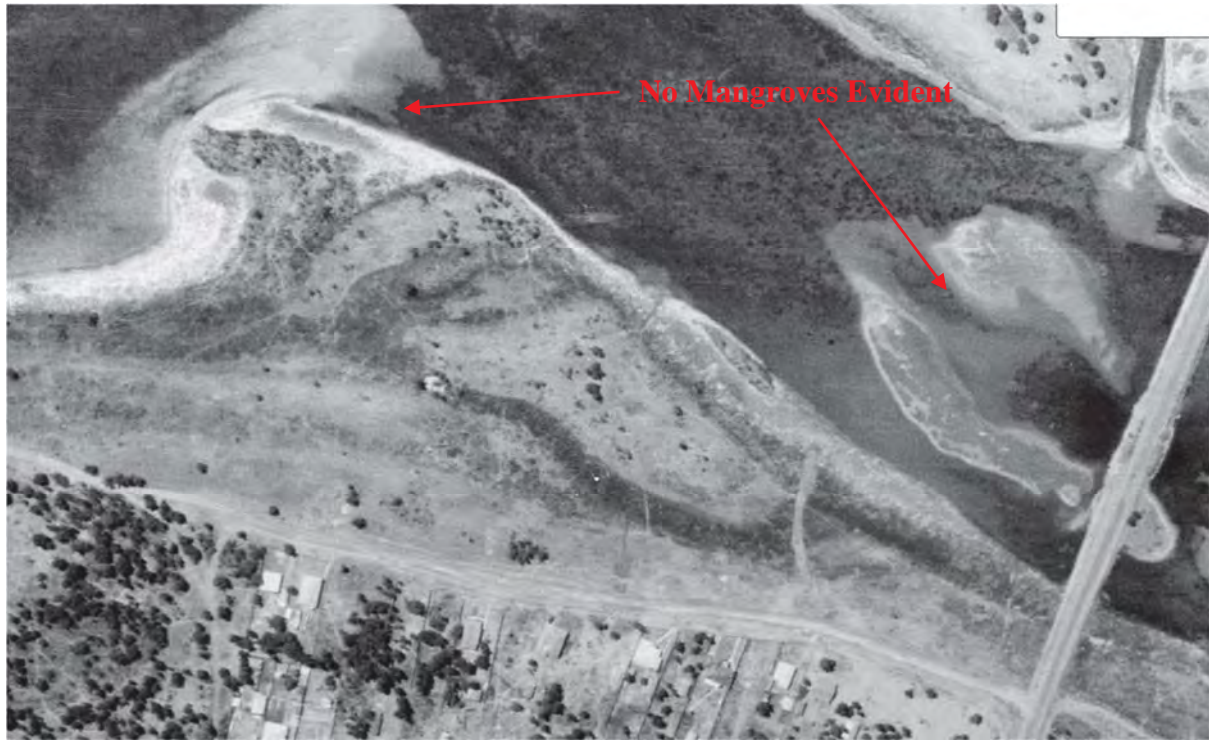
**Figure 5: Composite aerial imagery from 1948-1951 of the southern foreshore immediately west of Windang Bridge that shows the larger mangroves visible in later aerial photography are not yet present.**

It is possible that a limited number of mangroves may have been present in the Lake prior to those in aerial photographs from the 1970s, but none were documented and there are no other large mangroves present in the Lake today that could have grown from this time. A composite image from aerial photos taken between 1948-51 (Figure 5) clearly shows none of the mangroves visible in later images, so we assume trees established after this time. It is possible that small mangroves were present and died off, but were not visible in photography prior to the 1970s due to factors such as the quality of the photos and/or potentially being hidden by adjacent and overhanging vegetation.

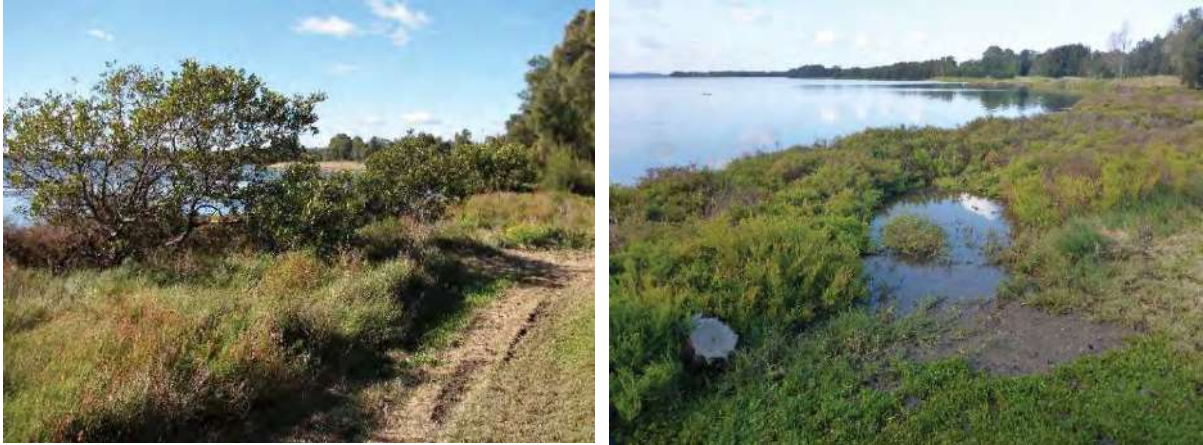
**Figure 7: Mangroves along the foreshore of Whyjuck Bay taken on 22/6/2010 (left) that have since been cut down with the stumps still visible (right, taken 12/4/06) (D. Wiecek, OEH).**

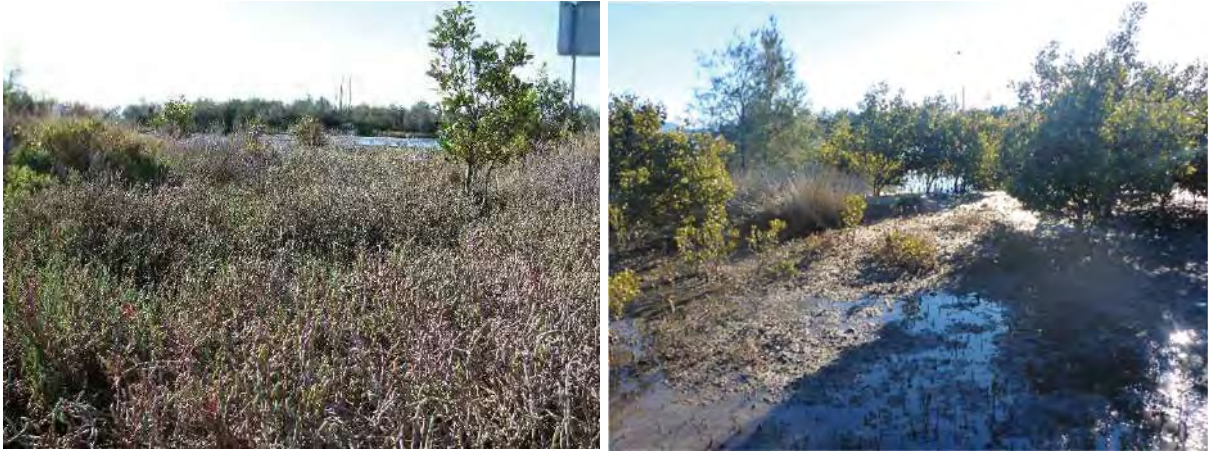
**Figure 8: Photo of the southern foreshore in the entrance back channel with thick growth of samphire dominated saltmarsh and a couple of young mangroves establishing taken 10-6-2010 (left), compared to a recent photo (8/8/2017) from the same location showing mangroves amongst mud with most saltmarsh, particularly samphire, gone (right) (D. Wiecek, OEH).**

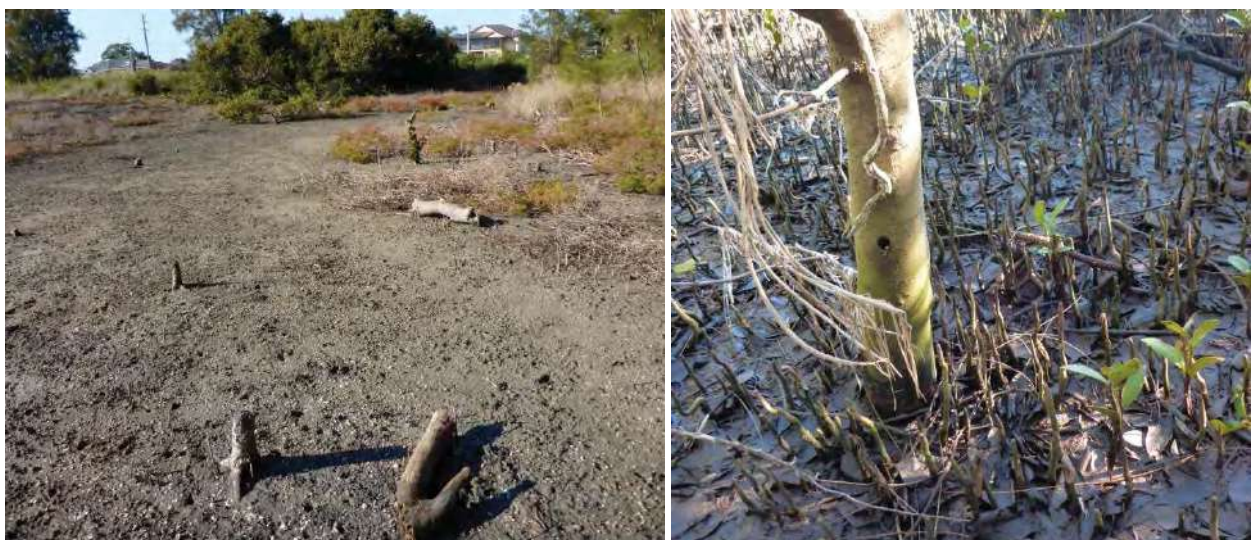
**Figure 10: Examples of mangrove vandalism adjacent to the PCYC Club, showing stumps remaining from mangrove trees cut down (left) and a drill hole injected with poison in a mangrove tree (right) (D.Wiecek, OEH).**
