## **STRUCTURAL ASSESSMENT REPORT**

**Albion Park Butter Factory (Former)  
23 Calderwood Road, Albion Park NSW 2527**

**INGLIS Project No: 2020136  
Report Reference No: 2020136-RPT-001**

**Report Date: 18 August 2021**

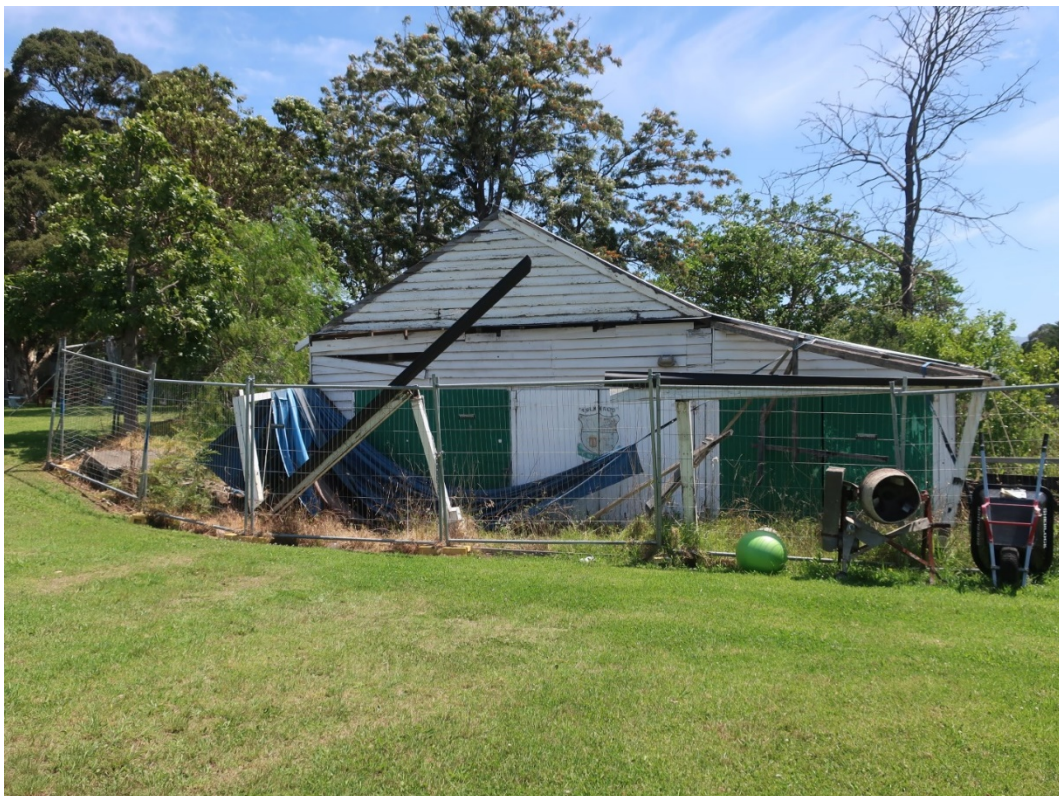
**Photograph 3.1 - Eastern Elevation as Inspected**

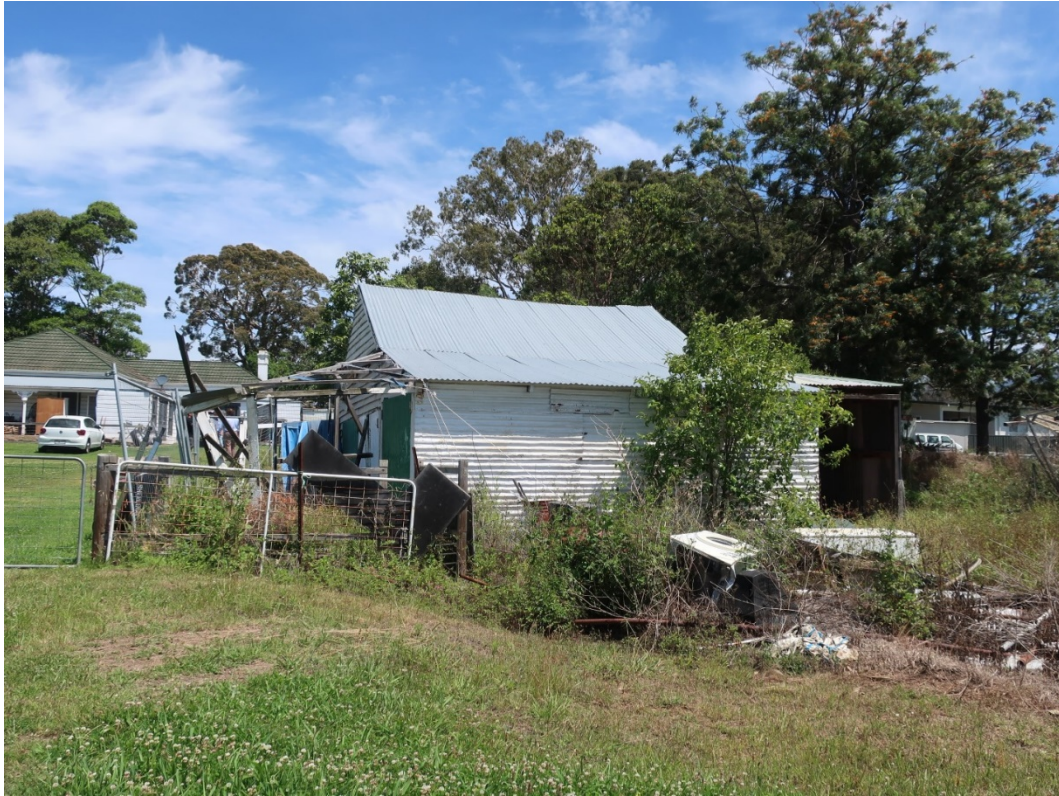
**Photograph 3.2 - Northern Elevation as Inspected**

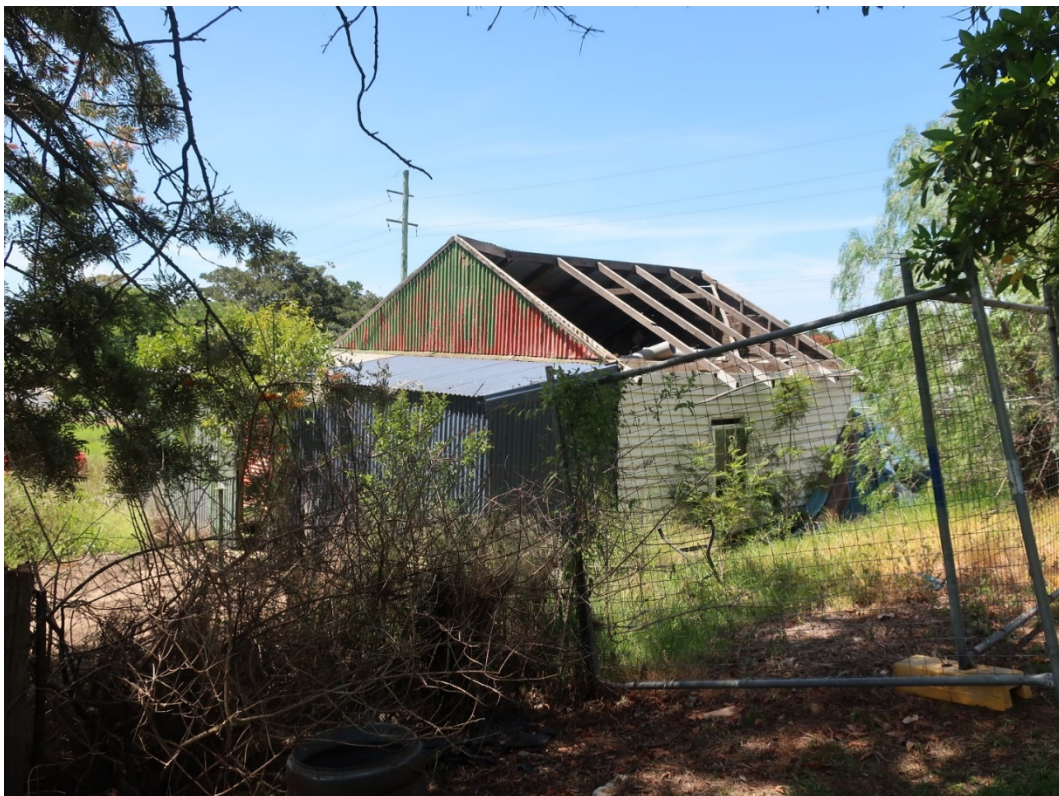
**Photograph 3.3 - Southern Elevation as Inspected**

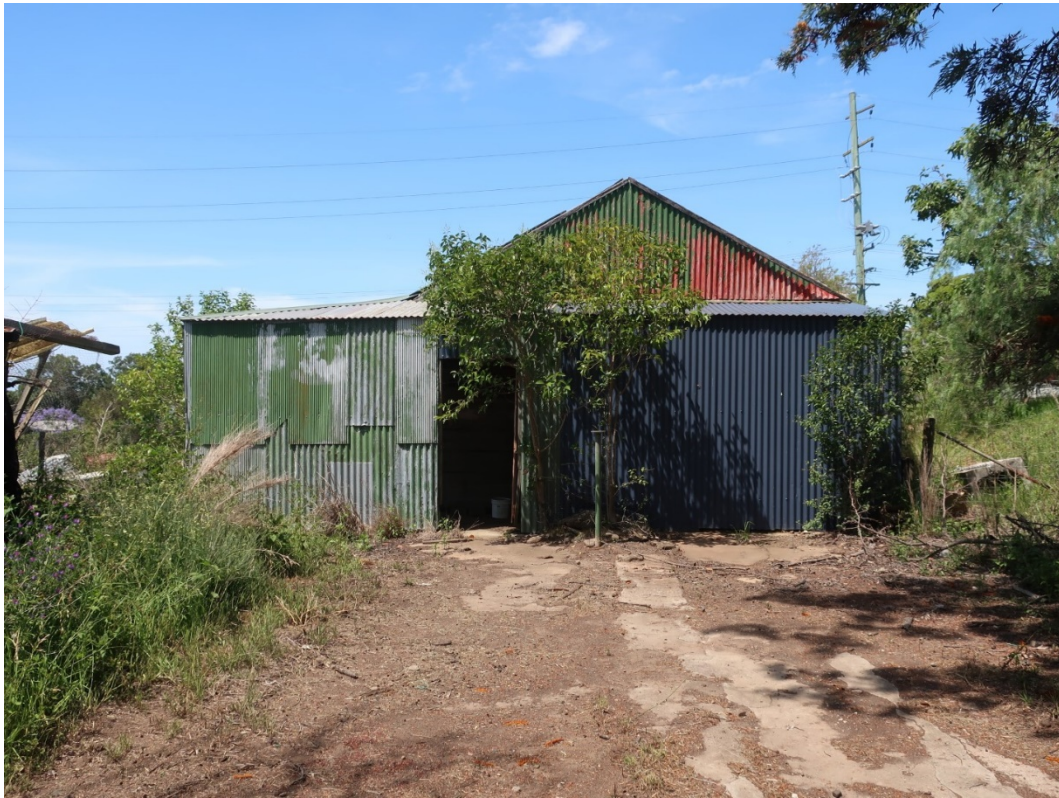
**Photograph 3.4 - Western Elevation as Inspected**

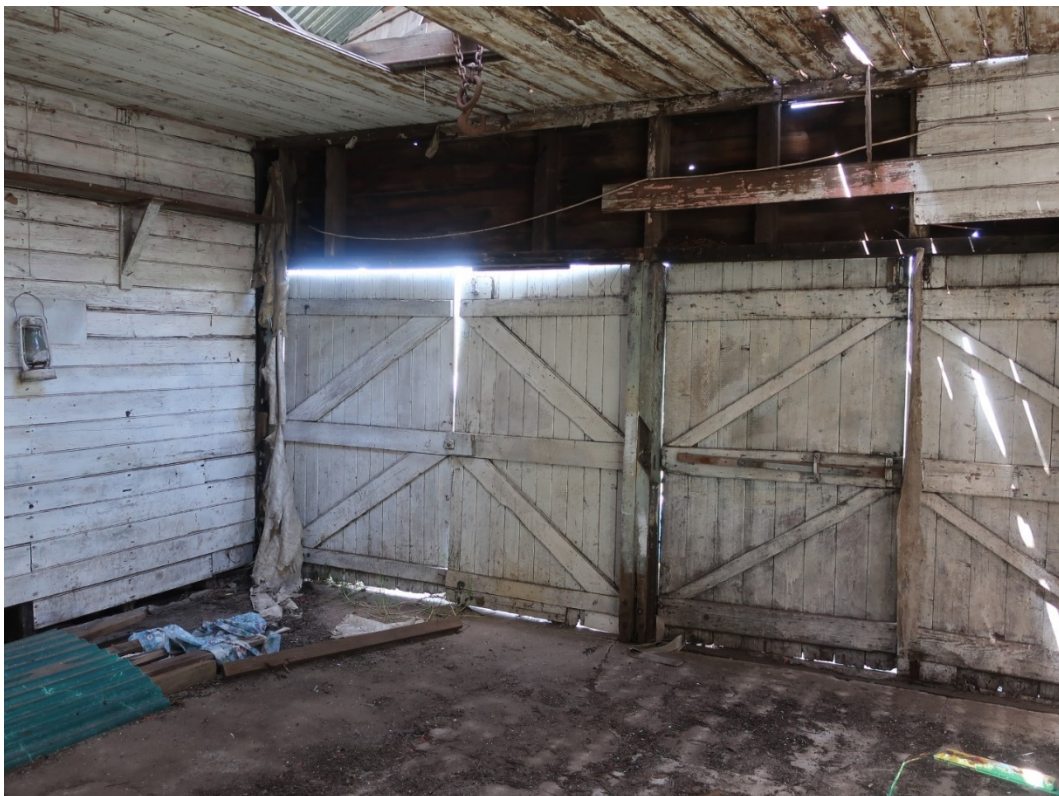
**Photograph 3.5 - Interior (Typical) as Inspected**
